AIB Bulletin

AIB Bulletin No. 4	Ref: CAV/CC/04/2005	Category: 1.2
Aircraft Type &Reg:	Cessna 402B; 5H-SKX	Serial No. 0829
No. & type of Engines:	Two, Continental TSIO-520E	
Year of Manufacture:	1975	
Date and Time (UTC):	7 April 2005 at 1120 hours	
Location:	Singida Airfield (S 04 48 66 E 034 43 50)	
Type of Flight:	Air charter	
Persons on Board:	Crew - 1 Passengers – 3	
Injuries:	Crew - Nil Passengers – Nil	
Nature of Damage:	Nose wheel collapsed. Damage confined to the nose wheel underneath area. Nose wheel cone and strut broken. One blade on the right propeller bent at the tip.	
Commander's License:	ATPL	
Commander's Age:	49 years	
Commander's Experience:	7,374 hours	
	Last 90 days:	90:05 hours
	Last 28 days:	12:35 hours

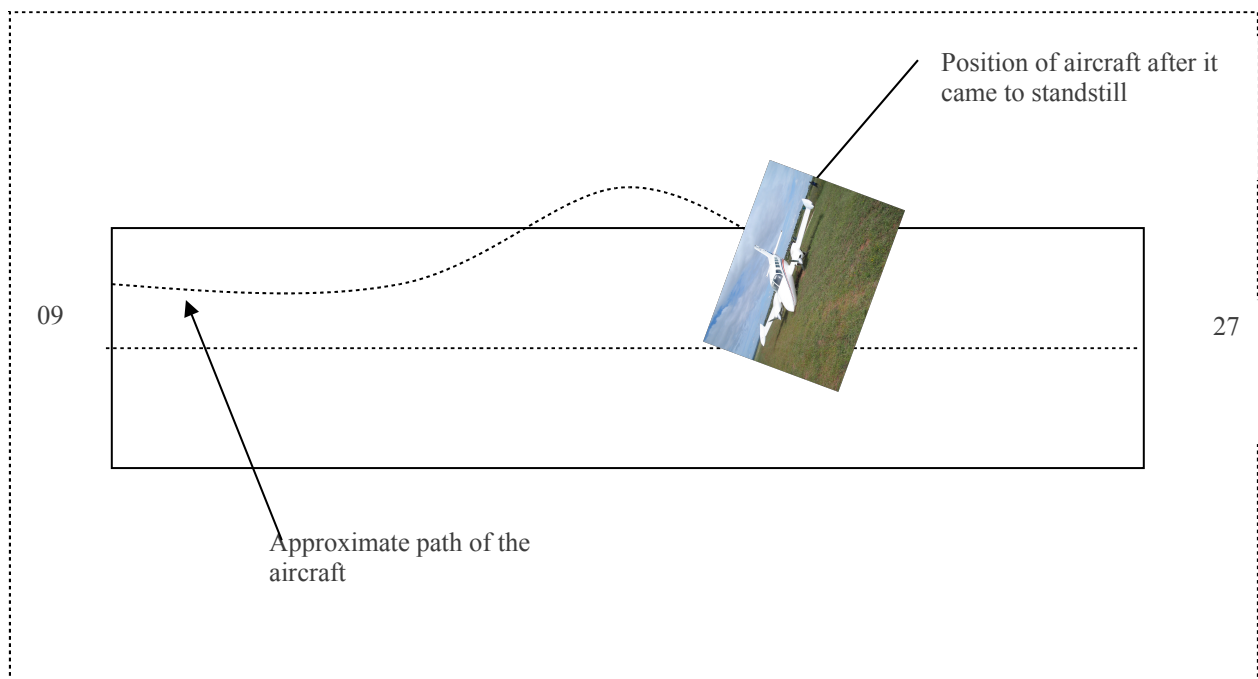
At 1111 hours the pilot applied full power on brakes with back pressure on the control column to ease load on the nose wheel. When the brakes were released, the aircraft rolled for approximately 350 metres when the nose wheel lifted up. Immediately, the aircraft rolled to further left of the centreline and at around 500 metres, it was completely out of the runway. In front, spectators who had gathered to watch the take off, saw the aircraft rolling towards them. After rolling a further twenty metres, the aircraft nose wheel regained the ground and engines were throttled back. Heavy braking with full right rudder were applied and the aircraft veered to the right into the runway. It stopped about 180 metres beyond the point where the nose wheel regained ground. The nose wheel upon hitting the ground, dug in and dragged the soft soil subsequent to which it collapsed. The right propeller hit the ground causing one propeller blade to bend. No damage was evident on the left propeller.

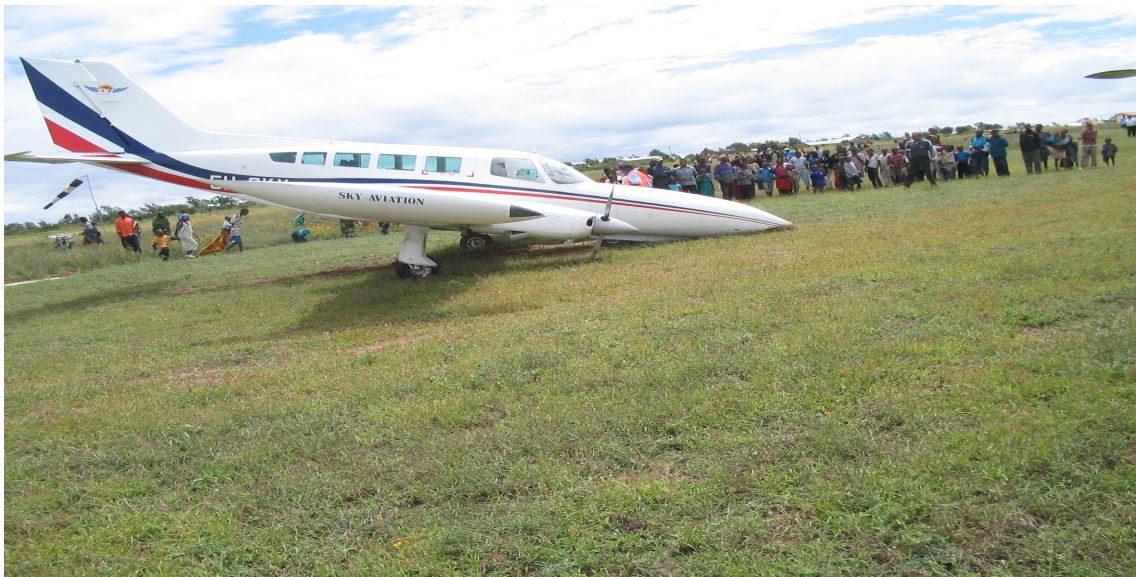
The damage to the aircraft was consistent with the nose landing gear collapsing during the take-off roll. Examination of the nose landing gear assembly showed that the landing gear had collapsed, retracting backwards. This caused damage to the nose cone. The right propeller hit the ground, causing one blade to bend at its tip. The damage was confined to this area of the nose landing gear.

The rudder was in full right deflection which was confirmed by the right rudder pedal in the cockpit that was in full forward position. Examination of cockpit showed all switches, indicators, throttle levers, RPM indicators in normal positions consistent with engines being cut off normally.

The accident was caused by the aircraft nose landing gear digging into soft soil and collapsing as the pilot tried to abort the take off.

- (1) Operators should ascertain conditions of destination airports prior to dispatching their flights.
- (2) Aerodrome operators should ensure current airports status are made available to users.
- (3) Airports available for use throughout the year should be maintained to cater for aircraft landing and take-off for the entire period.
