# AIB Bulletin

**AIB No. 6** Ref. CAV/ACC/6/10 Category: 1.3

**Aircraft Type:** Cessna U206G Reg. 5H-MVI Serial No. 206-04655

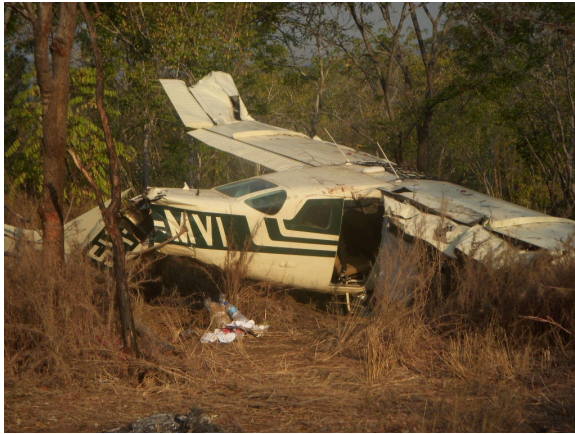
The wreckage was found on a ridge in the middle of a rain forest located in the Mikumi National Park. The exact location of the crash site was 18.51 nautical miles (34.3 km) N86°W of Matambwe airstrip. There was no fire damage. The aircraft collided with trees before and after touchdown and came to rest 42 metres beyond the first tree of impact. This tree was chopped by the left wing at a height of approximately 10 metres.

Main wreckage

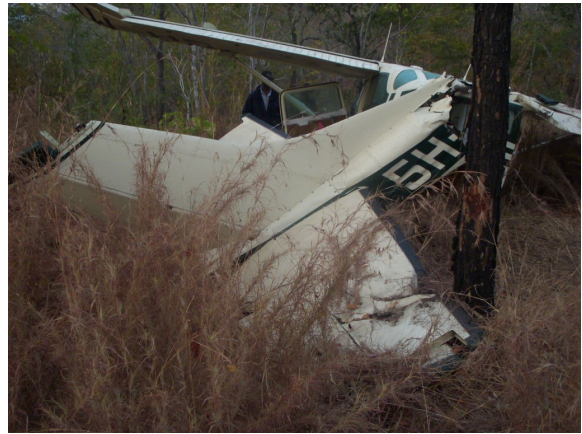
Tail section – note damage to horizontal stabilizer

The rear fuselage section was partly detached from the main fuselage as a result of the right horizontal stabilizer colliding with a tree. The engine also separated from its mounting points but remained held on to the aircraft by cables.

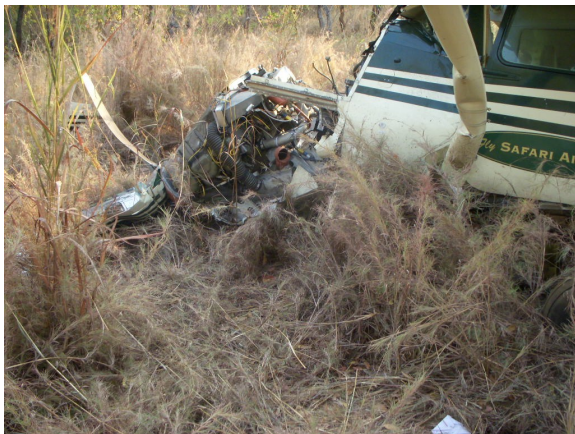
Engine

The damage to the propeller indicated that the engine was inoperative at the time of impact with the terrain. The engine was itself partially separated from the aircraft as a result of one propeller blade digging in when the aircraft was turning.

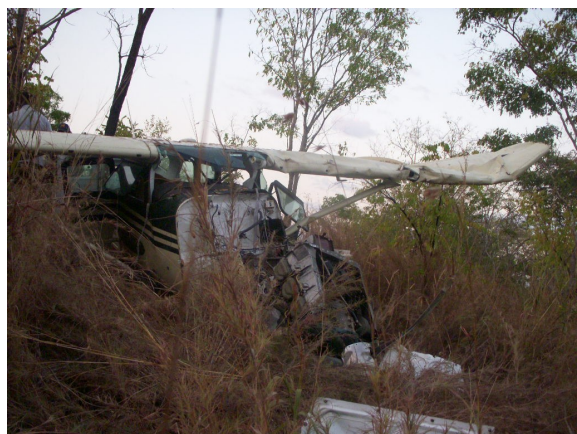
Front section

The left wing suffered extensive damage to its leading edge. The damage to the right wing was confined to the flap and aileron. The nose landing gear separated in the accident sequence. The right main wheel also separated from the gear spring after colliding with a stump. This collision had the effect of turning the aircraft through 90 degrees before it came to rest. There was no damage to the left main landing gear. The baggage pod contacted the ground when the two landing gears separated. It assisted in slowing down the aircraft and was damaged in the process.

The wind shield broke into large pieces on collision with the vegetation. However, these pieces did not cause injuries to the occupants.

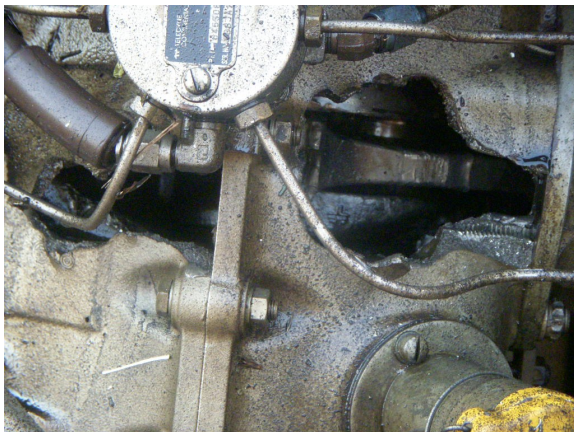
Punctured crank case

The engine crank case was found splattered with engine oil on the top surface. The crank case was punctured near cylinders number 4 and number 3. The bigger hole in the crank case was found in the position of the No.4 cylinder. This appeared to have been caused by the failure of the connecting rod number 4. The connecting-rod failed at the big end bearing. The oil filter was found to contain metal particles that were typical of bearing failure.

The force landing inside a forest was necessitated by the engine stoppage in flight. The engine was found to have seized due to lubrication failure. The in-flight engine seizure was initiated by the fracture of the number 4 connecting rod. The connecting rod appears to have fractured at the big end as a result of bearing failure.

Physical examination of the failed parts and the oil filter point to the number 4 crank shaft bearing failure from over temperature. In the circumstances, over temperature could have occurred as a result of oil starvation.

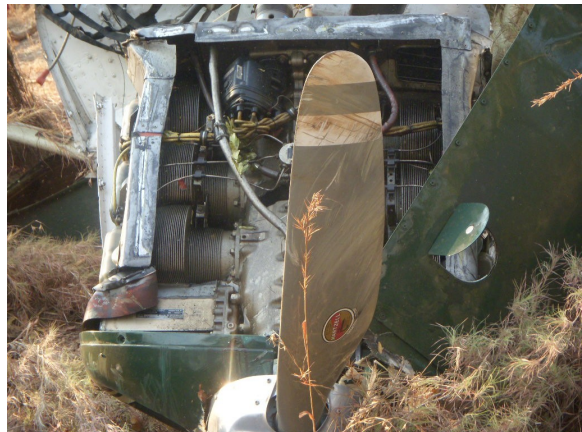
Propeller blade – no power indication
