AIB Bulletin

AIB Bulletin No. 1/00 **Ref.:** CAV/ACC/1/00 **Category:** 1.1
Aircraft Type & Reg. Boeing 707 -351C ST-APY **Serial No.** 19412
No. & type of Engines: 4 Pratt & Whitney JT 3D
Year of Manufacture: 1967
Date and Time (UTC): 3 February 2000 at 1736hrs
Location: Lake Victoria, Mwanza 4km short of Rwy 12 [0227 S 03256 E]
Type of Flight: Air Charter, Cargo
Persons on Board: Crew - 5 Passengers - Nil
Injuries: Crew - Nil Passengers - N/A
Nature of Damage: All engines ripped off, damage to both wings. Nose landing Gear separated taking with it much of the forward lower fuselage structure
Commander's Licence: NOT KNOWN
Commander's Age: NOT KNOWN
Commander's Experience: NOT KNOWN

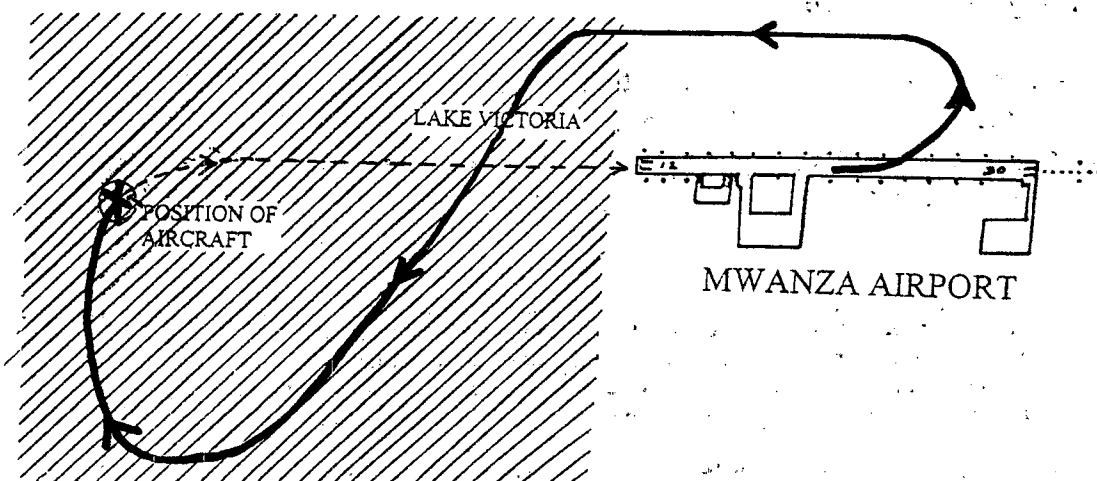
According to the controller, the aircraft subsequently descended very low over the lake and came close to the water level while it was still far from the threshold of runway 12. He cautioned the pilot over the height but there was no reply. Moments later, he saw the aircraft fall into the lake with a bang.

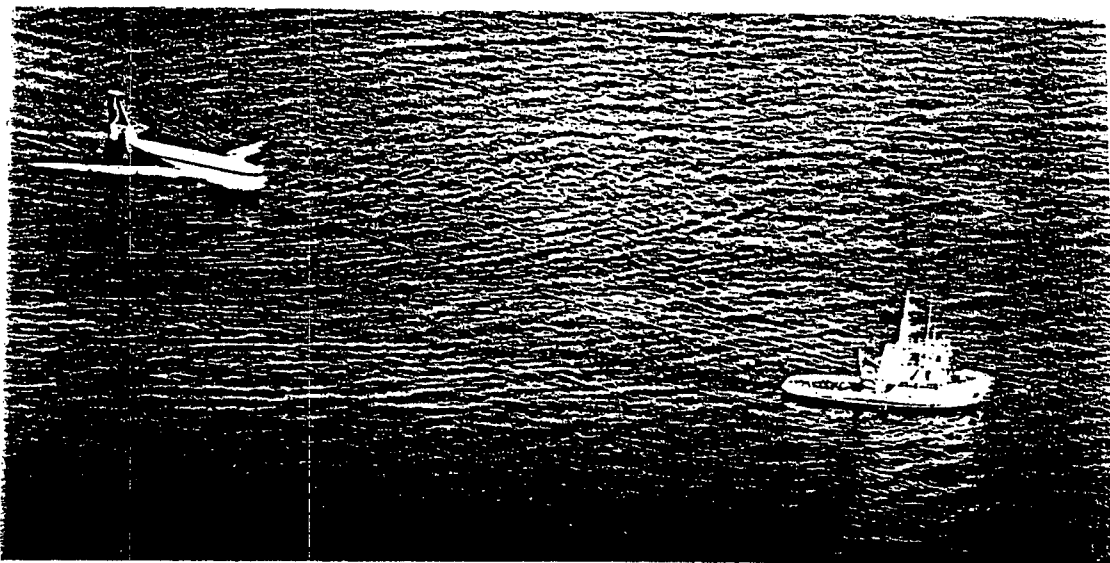
The aircraft came to rest in the lake about 4km short of runway 12. There was no fire. On the following day some 18 hours after the accident it had drifted further in the waters and was 11.6 km on bearing 290° from the threshold of the runway. It was floating freely with the tail section partly submerged but the forward fuselage was standing at an angle, clear of the water.

The aircraft was later towed to a position close to the shore. There was fuel leakage and the surrounding waters were contaminated with fuel.
