THE UNITED REPUBLIC OF TANZANIA
MINISTRY OF COMMUNICATIONS AND TRANSPORT
ACCIDENT INVESTIGATION BRANCH

AIB Bulletin No. 10/00 **Ref.:** CAV/ACC/10/00 **Category:** 3

Aircraft Type & Reg. Hornet Trike Microlight **Reg.** 5H-HSC **Serial No.** 029

Date and Time (UTC): 19th August, 2000 at 0820 hours

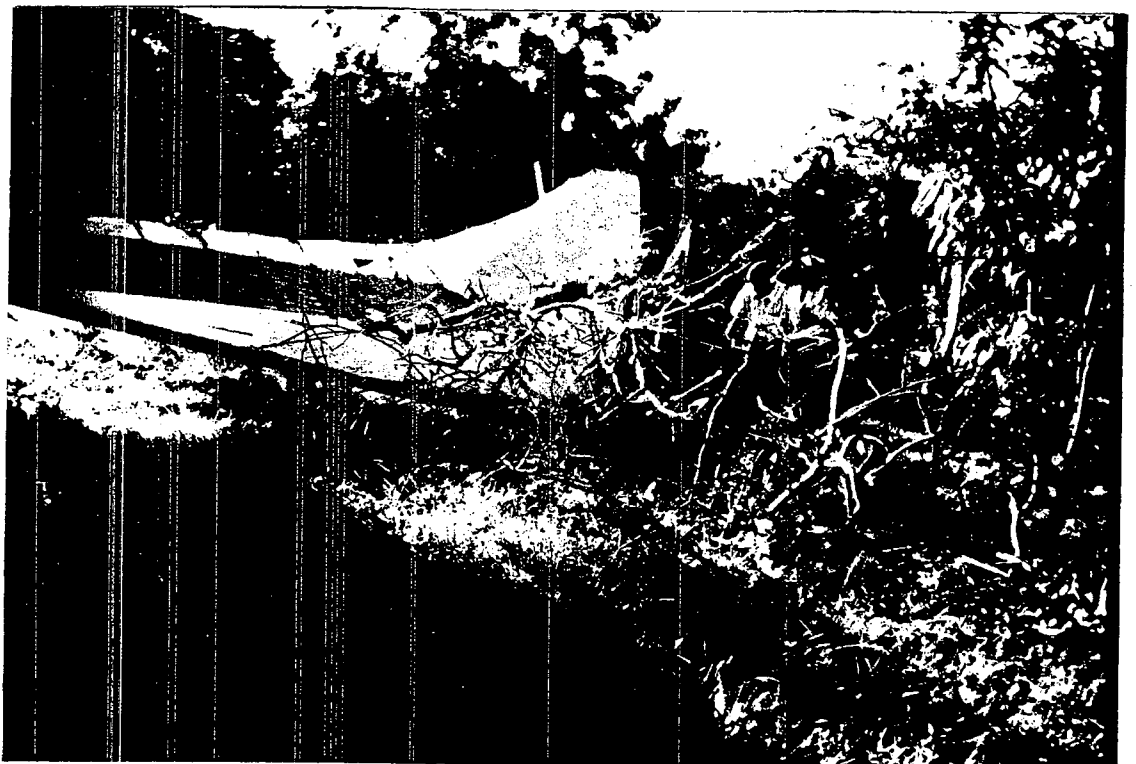
The engine and the propeller showed no signs of damage. The fuel tank was also found intact and was about two-thirds full. Much of the damage was to be found on the wing, and supporting beams, the nose landing gear and the instrument panel.
