THE UNITED REPUBLIC OF TANZANIA
MINISTRY OF COMMUNICATIONS AND TRANSPORT
ACCIDENT INVESTIGATION BRANCH

AIB Bulletin

AIB Bulletin No. 11/00 **Ref: CAV/CC/11/00** **Category: 1.3**

Aircraft Type & Reg. Cessna 210L Reg.ZS-MXB **Serial No. 61362**

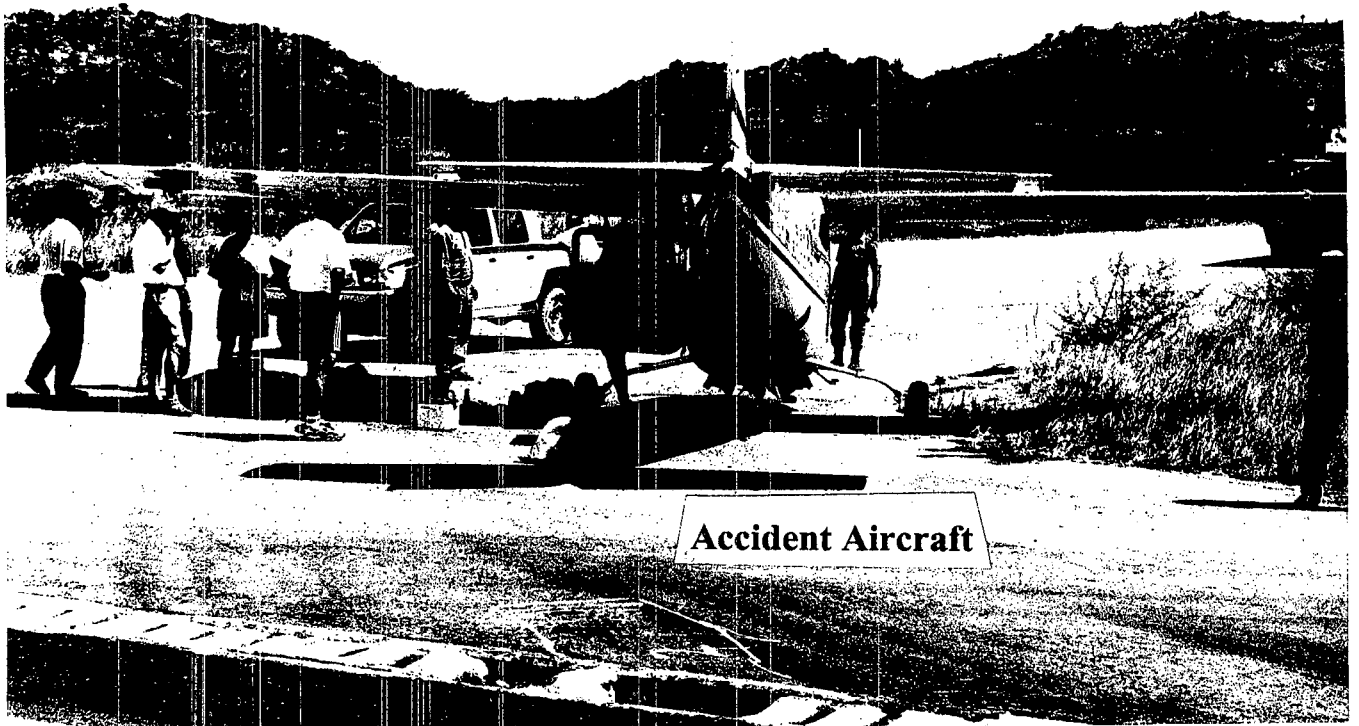
Nature of Damage Nose landing gear fork broken, propeller strike damage.

Accident Aircraft

Whilst proceeding to the taxiway and at the edge of the runway, the nose landing gear failed, causing the propeller to strike the ground. He then realized that the nose wheel had run over a concrete slab covering a drainage trench and that the slab has collapsed causing the nose wheel to be imbedded in the trench. As it did so, its fork sheared and the propeller struck the tarmac surface of the taxiway before the aircraft came to rest. There was no fire and all the four occupants were not injured

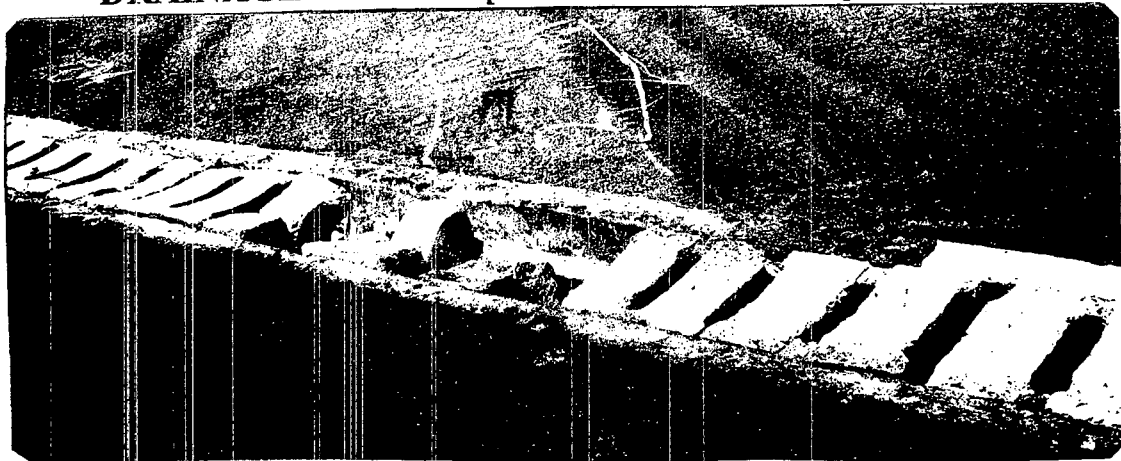
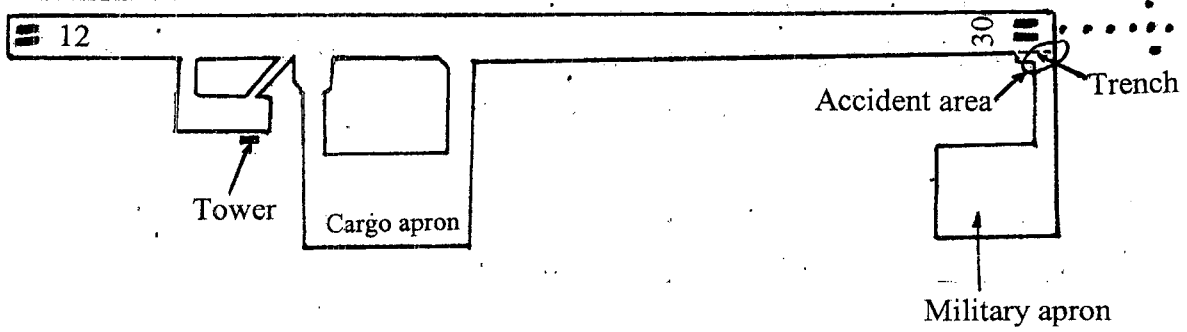
DRAINAGE TRENCH [Note the broken slabs]

Mwanza Airport, elevation 3763 feet has one runway 12/30 which is 3300 meters long and 45 meters wide. The surface is tarmac and was in good condition at the time of the accident. The runway has neither parallel taxiways nor turning pads. All aircraft have to taxi and turn on the runway itself. Large transport aircraft backtracking runway 30 have to use part of the military taxiway to effect the turning to the threshold. In doing so, they have, over the years, damaged the concrete slabs covering the drain trench between the taxiway and the military apron. The slabs were laid in 1980 for the passage of jet fighters. They have since not been changed. At the time of the accident some of these slabs were cracked and a few of them were broken.
