# AIB Bulletin

AIB Bulletin No: 13/00 Ref: CAV/ACC/13/00

Aircraft Type :	DC8-54F	Reg. 3D-AVD	Serial No. 46012
No & Type of Engines:	4 Pratt & Whitney JT3D-3B		
Year of Manufacture:	1969		
Date: & Time (UTC):	12 October 2000 at 2253 hours		
Location :	Mwanza Airport (Lat. 0227S Long. 3256E)		
Type of Flight:	Air Cargo		
Persons on Board.	Crew-4	Passengers-NIL	
Injuries:	Crew-NIL	Passengers-N/A	
Nature of Damage:	Damage to right main landing gear lower oleo strut and bogie beam.		
Commander's Licence:	ATPL		
Commander's Age:	54 years		
Commander's Experience	17,000 hours of which 12,000 were on type		
	Last 90 days 200 hrs		
	Last 28 days 70 hrs		
Information Source:	Telephone call from Mwanza ATS

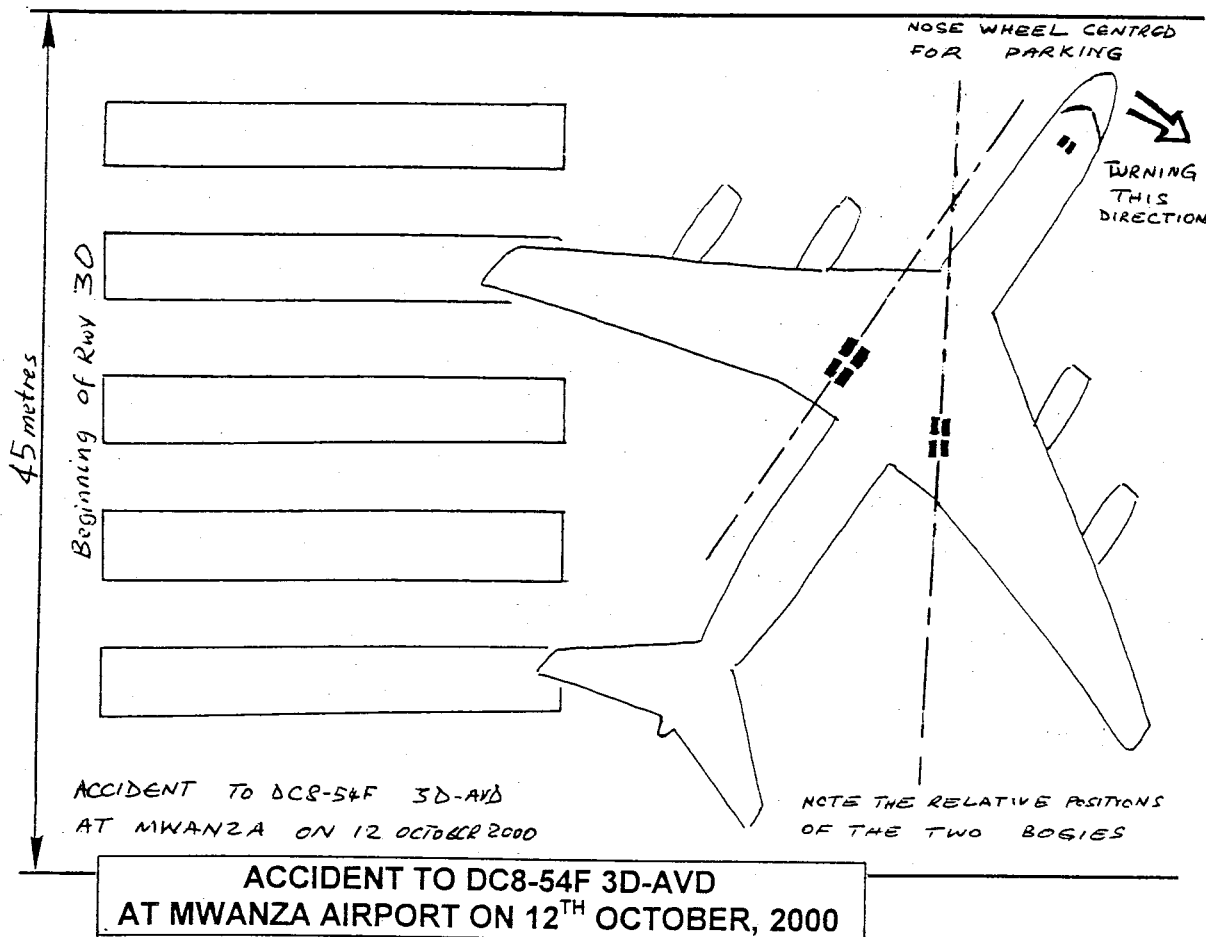
The commander said that whilst conducting a 180° turn at the beginning of runway 30 the crew heard a loud bang and aircraft was stopped immediately. The flight engineer was dispatched down using the escape rope from the main door to investigate. He reported damage to the right main landing gear bogie beam, extensive damage to the casting around the pivot pin and inner landing gear strut. The aircraft was subsequently shut down on that spot and the freight was off-loaded. The aircraft remained here for two days waiting for spares. It was feared that attempts to move the aircraft would cause the damaged landing gear to collapse. Examination of the right main landing gear assembly showed that the inboard lug of the fork end of the lower oleo strut had fractured. The fracture surface showed evidence of overload failure and a small fatigue crack. A brake compensating rod fractured in the accident sequence and jammed against the No. 3 front main tyre.

Visual inspection showed that while the aircraft was negotiating the turn to runway 30 centre-line, the right main bogie did not turn nor did the bogie beam unlock to allow relative movement of its two axles. The right bogie beam thus resisted the twisting effect of the right main landing gear strut causing the lower oleo strut fork end lug to fail.
