AIB Bulletin

AIB Bulletin No. 16 **Ref.:** CAV/ACC/16/00 **Category:** 1.3

Aircraft Type: Cessna 206 **Reg.** 5H-IBB **Serial No.** 04764

Location: Kiba airstrip, Selous Game Reserve
Lat 07° 44' 60"S Long. 038° 00' 20"

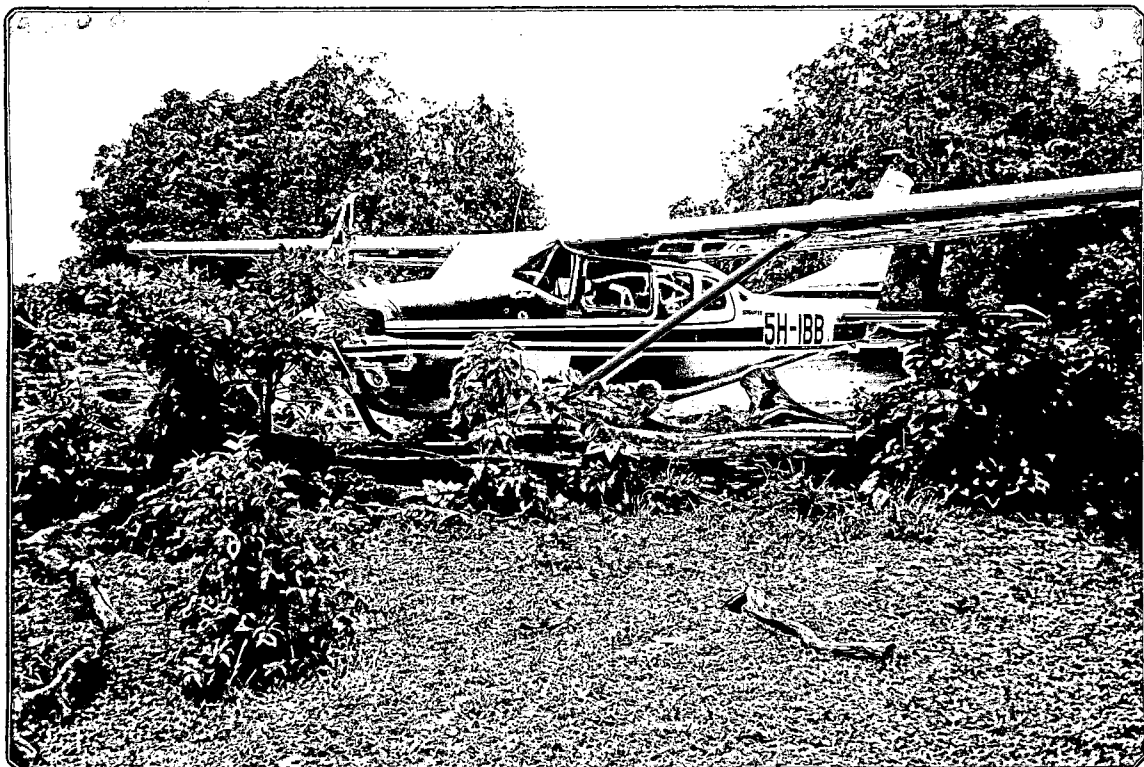
An eye witness who was at Kiba airstrip reported heavy braking down the runway and as it did so the aircraft was seen to drift sideways whilst causing a "dust storm". It was subsequently observed to overrun the end of the runway, colliding a log of a felled large tree (2 feet diameter) which was lying just beyond the end of the runway. The aircraft came to rest at the collision point.

All the three blades of the propeller were bent as a result of striking the log. There was minor damage to the left wing strut fairing and the baggage pod.

Kiba airstrip, elevation 600feet has one unpaved runway 02/20 which is about 1000 metres long. Runway 02 has an uphill slope starting midway and rising for a further 150 metres before it levels off. The last 100 metres or so has a slight downward slope. There were trees located just beyond the end of the runway. 5H-IBB would have been stopped safely had the aerodrome operator observed the end of runway clearway requirement. In 1998 TCAA directed all aerodrome operators in Game Reserves to clear the strips 40 meters beyond both sides of each runway and 60 meters beyond both ends.
