THE UNITED REPUBLIC OF TANZANIA
MINISTRY OF COMMUNICATION AND TRANSPORT
ACCIDENT INVESTIGATION BRANCH

AIB Bulletin

AIB Bulletin No. 17/98	:	Ref: CAV/ACC/17/98	Category: 1.3
Aircraft Type & Reg	:	Cessna U206F; N36MS	S/N 02096
No. & Type of Engines	:	One Continental IO-520F 3B	
Year of Manufacture	:	1973	
Date and Time	:	17 September 1998 at around 0650 hours	
Location	:	Monduli Hills (Bwawa la Zamani) (031500S 03629656E)	
Type of Flight	:	Private	
Persons on Board	:	Crew - 1	Passengers - 3
Injuries	:	Crew - 1 Killed	Passengers - 2 Killed - 1 seriously injured
Nature of Damage	:	Aircraft completely destroyed	
Commander's Licence	:	Private pilot's Licence (FAA)	
Commander's Age	:	54 years	
Commander's Experience	:	3600 hours (of which 93 were on type) Last 90 days - 65 hours Last 28 days - 23 hours	
Information source	:	Telephone call from Arusha ATS

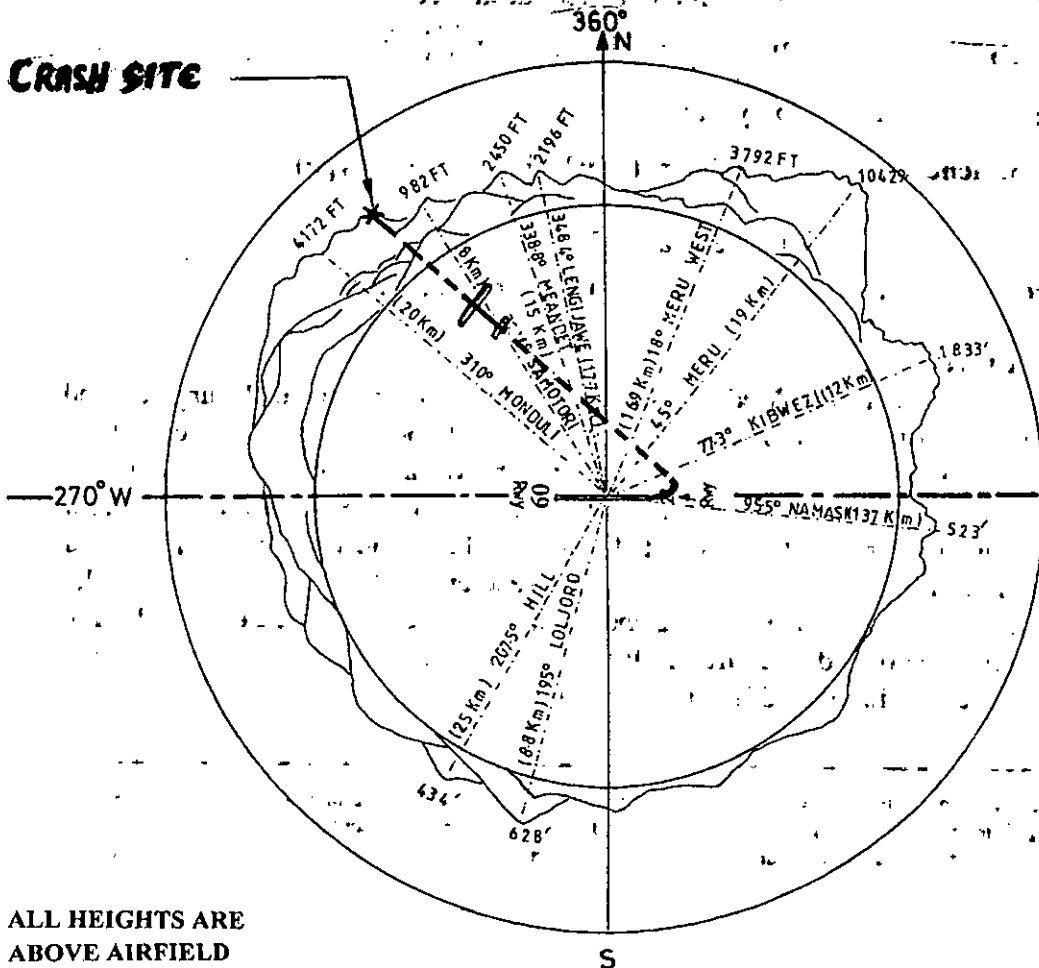
HEIGHT AND DISTANCE OF VISIBILITY POINTS

ARUSHA AIRPORT: Height Above Mean Sea Level 4550 feet

ALL HEIGHTS ARE ABOVE AIRFIELD
