# AIB Bulletin

AIB Bulletin No: 18/99

Piper PA32-300 5H-MTU Serial No. 32-40541

### ACCIDENT TO PIPER PA 32-300 5H-MTU NEAR AMANI GOMVU AIRSTRIP ON 11 DECEMBER 1999

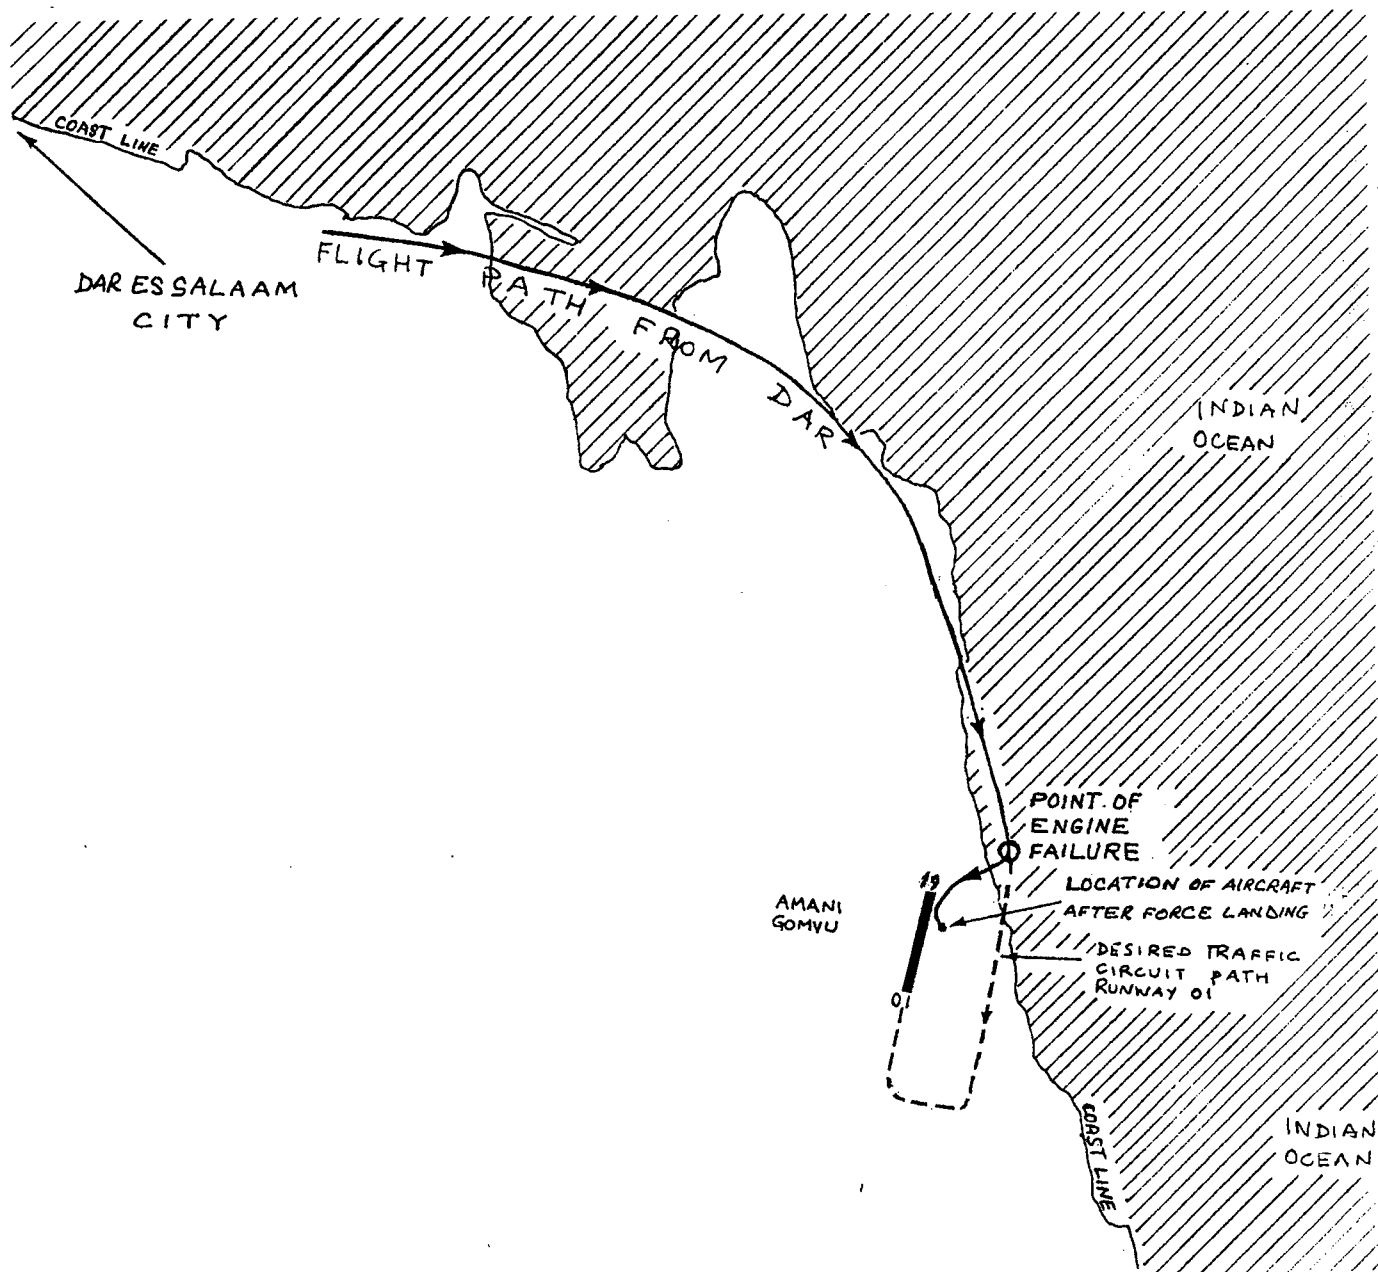
The aircraft touched down on a stretch of grass just beyond some tall trees on an approximate heading of 220<sup>o</sup> and rolled for 78 metres before the left wing collided with bush trees and separated. The left wing subsequently lifted off the aircraft, flew across the fuselage and landed just beyond the path of the left wing. As the aircraft continued to roll, the left horizontal stabilizer collided with a thick stump causing damage to the tail cone and the rudder. After covering a further 44 metres 5H-MTU came to rest facing 175<sup>o</sup> and was 58 metres beyond the left edge of runway 19 and 300 metres from the threshold of the runway.

There was no fire and the pilot was not injured. The aircraft sustained substantial damage to the left wing, the tail plane and the tail cone.
