AIB Bulletin

AIB Bulletin No. 3/00	Ref.: CAV/ACC/3/00	Category: 3
Aircraft Type & Reg.	MGN Microlight <i>SH-MGN</i>	Serial No. 001
No. & type of Engines:	One Lycoming IO-360-A36BD	
Year of Manufacture:	1998	
Date and Time (UTC):	11 June 2000 at 1315hrs	
Location:	Sugar cane field at Kizota Dodoma 1nm short of runway 10	
Type of Flight:	Private	
Persons on Board:	Crew - 1	Passengers - Nil
Injuries:	Crew - Nil	Passengers - N/A
Nature of Damage:	Substantial	
Commander's Licence:	PPL	
Commander's Age:	32 years	
Commander's Experience:	400 hours of which 30 were on type	
	Last 90 days 11 hrs	
	Last 28 days 11 hrs	
Information Source:	Telephone call from Dodoma ATS.

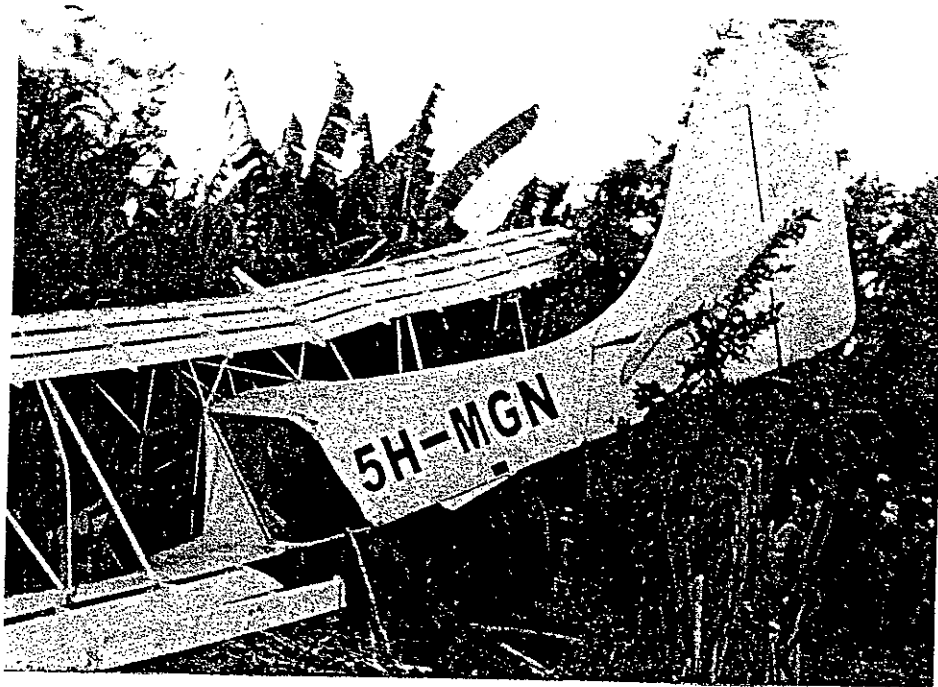
Shortly after touchdown the lower wings struck some trees. During the landing roll the left main landing gear hit a mound of earth and separated causing the aircraft to come to rest on the right main and the engine cowling. The aircraft sustained substantial damage to the left main landing gear, the oil radiator and part of the fuselage.

Examination of the fuel selector system showed that the screw holding the selector valve handle had come out and on switching tanks the handle separated.
