AIB Bulletin

AIB Bulletin No. 4/00	Ref: CAV/CC/4/00	Category: 1.2
Aircraft Type & Reg.	Cessna 425 5H-SCB	Serial No. 0183
No. & type of Engines:	2 PT6A-112	
Year of Manufacture:	1983	
Date and Time (UTC):	12 June 2000 at 1515 hours	
Location:	Nzasa Vibula Village near Chanika, Kisarawe District, 12.4 nm DME bearing 240° from Dar es Salaam	
Type of Flight:	Air Charter	
Persons on Board:	Crew - 1	Passengers - 7
Injuries:	Crew - Nil	Passengers - 2 Serious
Nature of Damage:	Aircraft destroyed by impact with the ground and vegetation.	
Commander's Licence:	CPL	
Commander's Age:	57 years	
Commander's Experience:	5416 hours of which 123 were on type	
	Last 90 days	102 hrs
	Last 28 days	8 hrs
Information Source:	Telephone call from Rescue Co-ordination Centre.

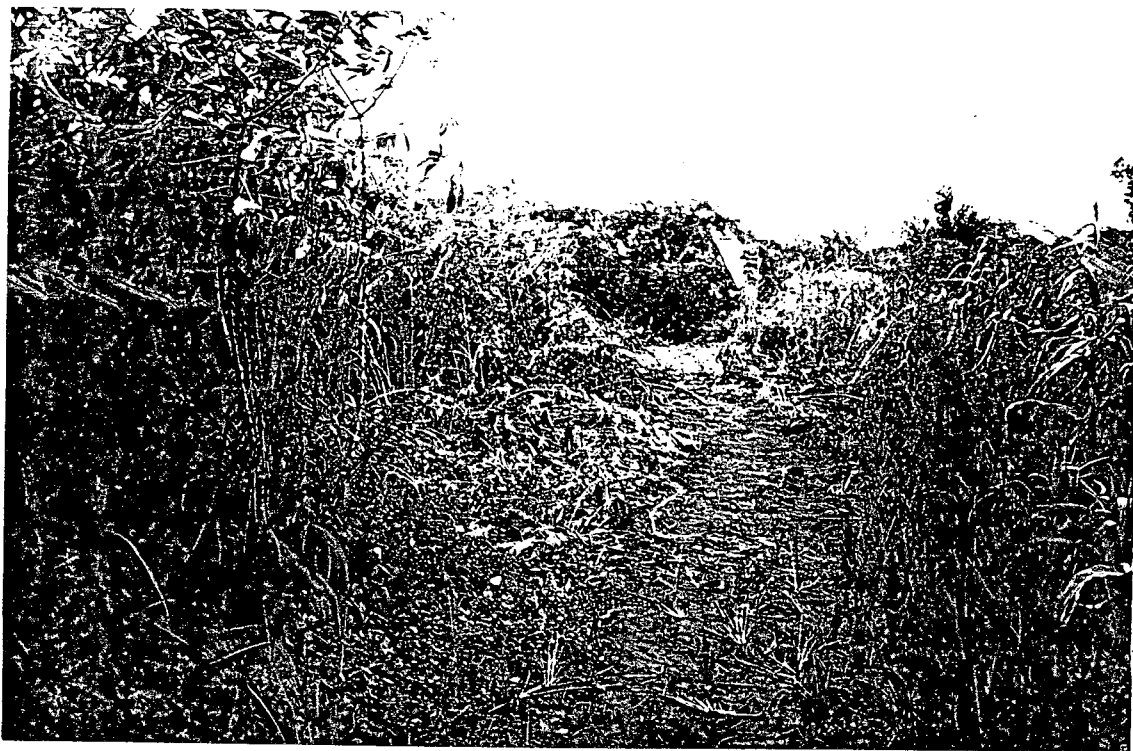
The wreckage came to rest in a banana/maize plantation which was overgrown with tall grass and a few tall trees. It was pointing in the direction 133 degrees.

It was evident from the wreckage trail that the aircraft rotated through 74 degrees when it collided with the last tree in the accident sequence. The impact marks were clearly visible on the right engine.

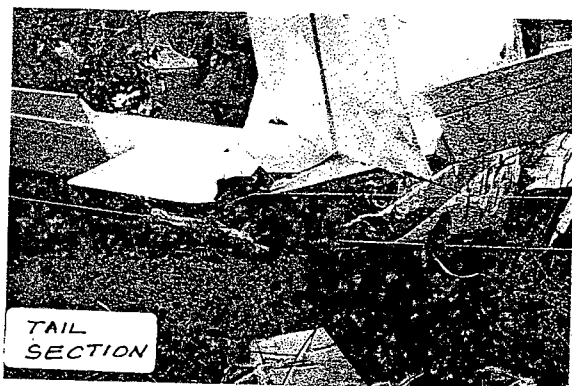
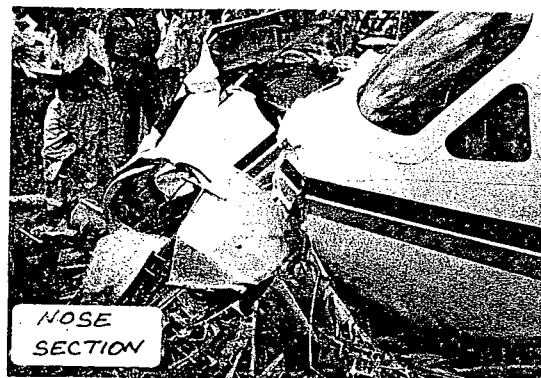
Examination of the ground impact marks and the damage to the aircraft showed that the aircraft was side slipping to the left at the first impact with the ground. It landed on the right wing bounced on the right main landing gear and nose followed by the tail section, the left main, and the left wing. The left main landing gear collapsed and the nose section partially separated.

Most of the impact loads were taken by the wings, the engines, the propellers, the belly, the tail section and the nose.

The cabin sustained relatively little damage. The damage to the cabin was confined to the distortions in the floor. There was no fire.

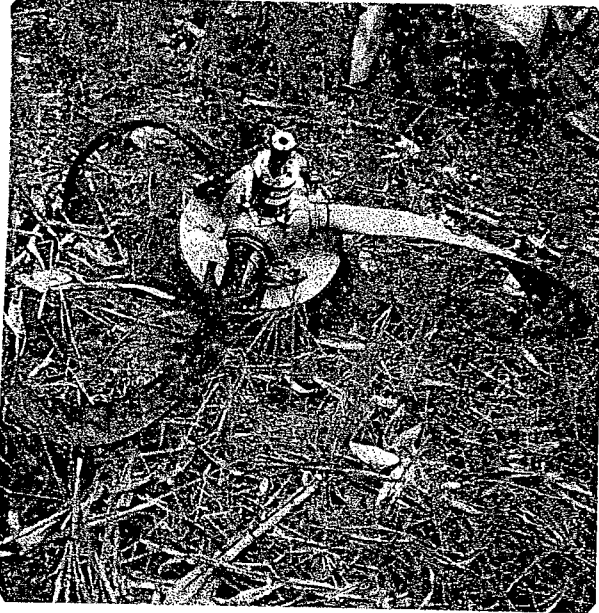
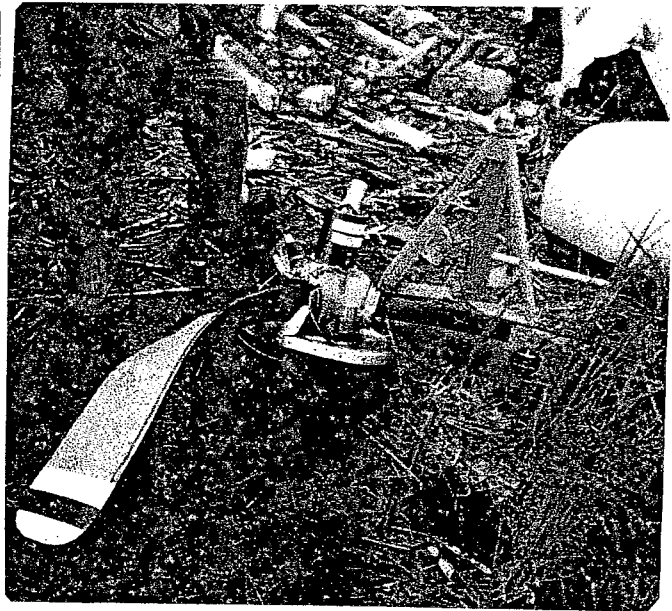
The damage to both propellers indicated that they were not under power at the time of impact.

The right propeller was feathered but the left propeller was in fine pitch.

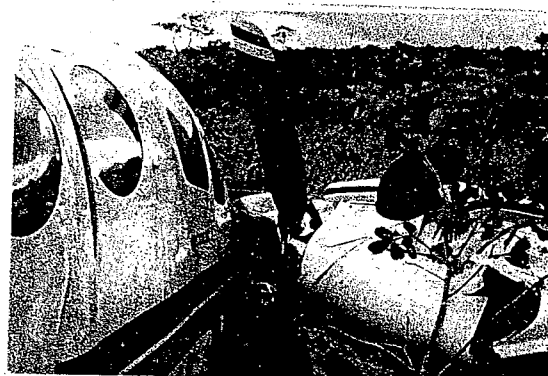
Both engines were almost completely detached from their wing positions and were all found pointing to the left.

It is considered that the engines detached when the wings collided with the ground and trees.

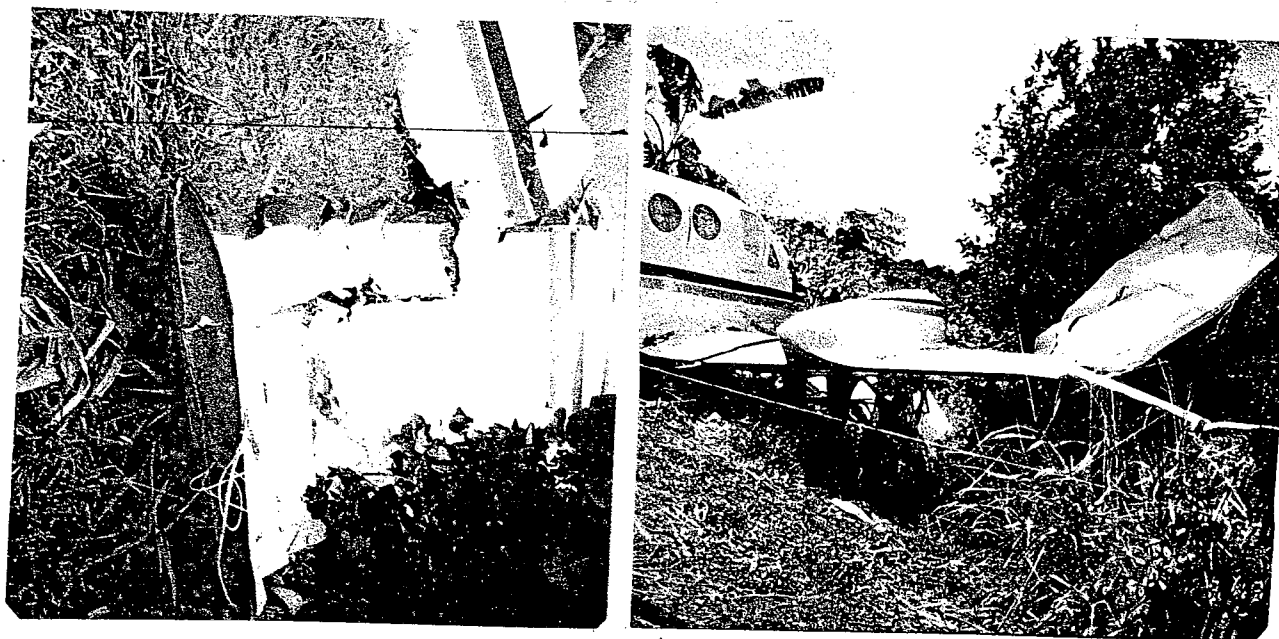
Much of the damage to the right wing occurred to the section five feet outboard of the engine which was bent upwards as a result of the ground impact. The aileron was partially detached. The flap which was up at the time of the accident sustained no externally visible damage. The wing root was also damaged.

The left wing impacted the ground in the accident sequence and collided with most of the vegetation. It also scraped the ground before the aircraft came to rest. This was because the left main gear collapsed probably in the second impact with ground. The left wing was completely destroyed in the accident and its engine separated.
