THE UNITED REPUBLIC OF TANZANIA
MINISTRY OF COMMUNICATIONS AND TRANSPORT

AIB Bulletin

AIB Bulletin No: 4/97	Ref: CAV/ACC/4/97
Aircraft Type	Cessna 404
Registration	5H-PAV
No & Type of Engines	Two Continental GTSIO-520M
Year of Manufacture	1980
Date & Time (UTC)	01 May 1997 at 0858 hours
Location	Bukoba Airport
Type of Flight	Scheduled Service
Persons on Board	Crew - 1 Passengers - 10
Injuries	Crew - 1 Passengers - 2
Nature of Damage	Aircraft substantially damaged.
Commander's Licence	Commercial Pilot's Licence
Commander's Age	42 Years
Commander's Flying Experience	7000 hours
Information Source	Telephone call from Mwanza ATS

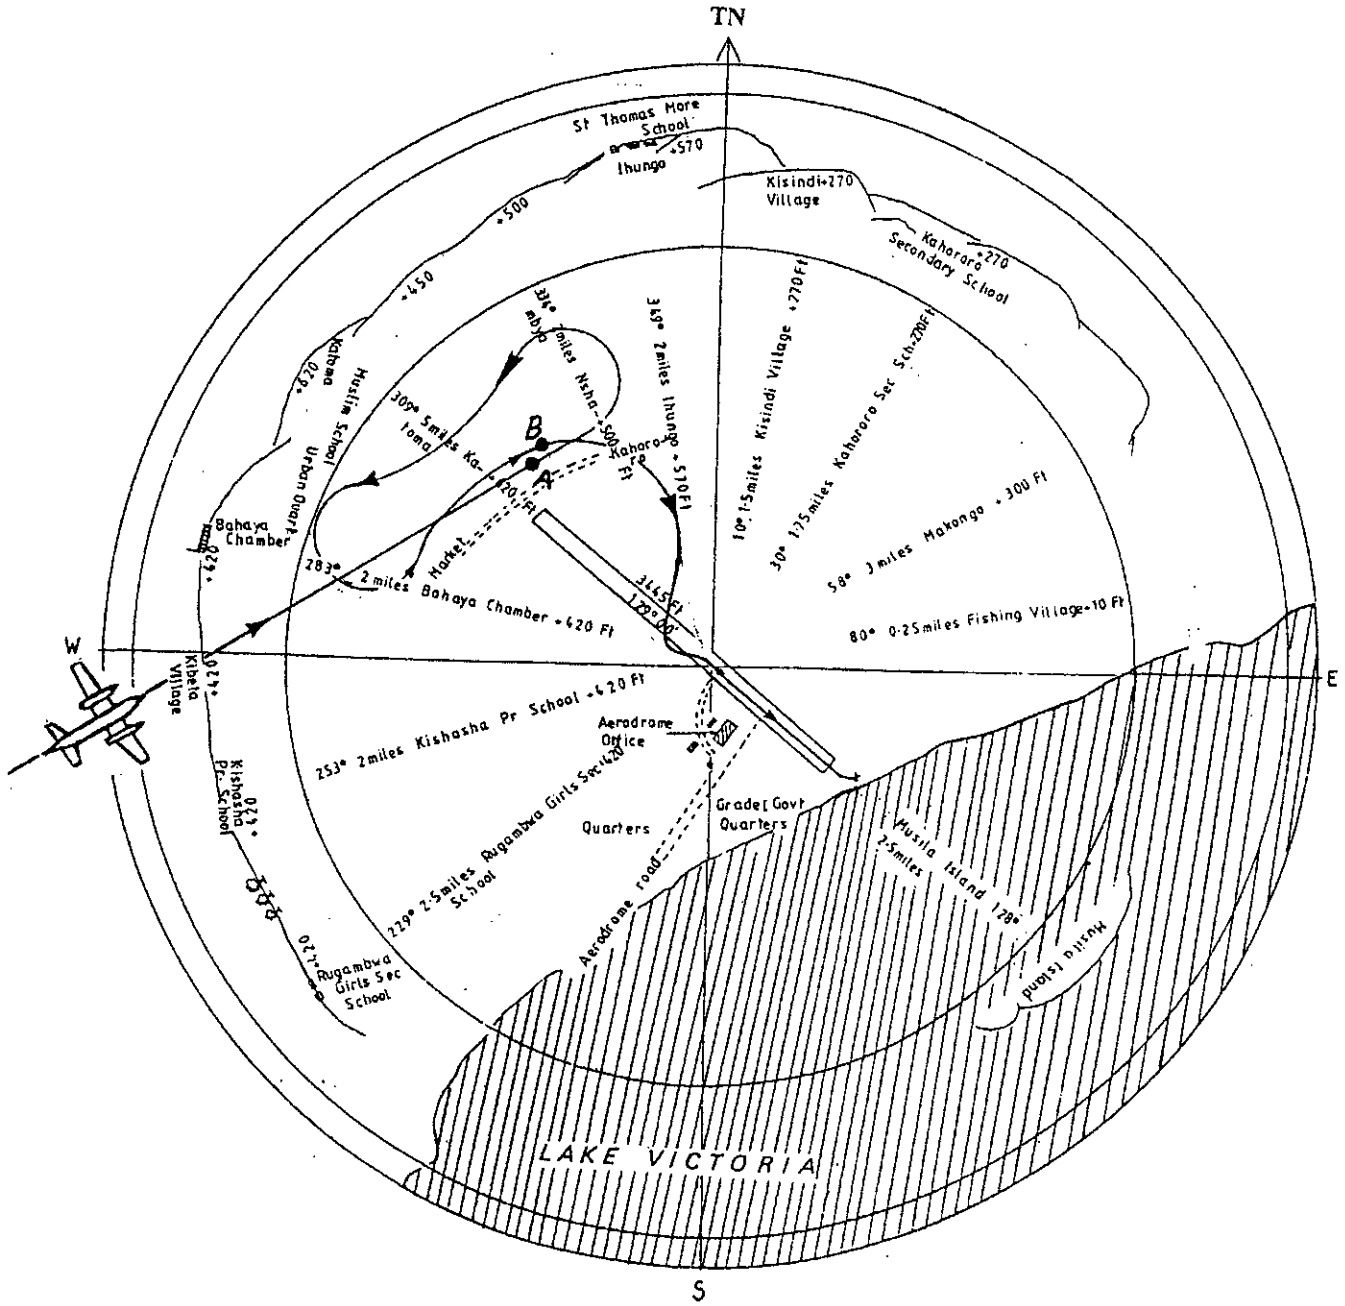
APPENDIX 1
 Estimated aircraft ground track

The aircraft was reported to have flown across the runway from the South West, turned left, climbed over the Nshambya hills (appendix 1) and made an approach to runway 13. On short finals the pilot said that he could not see the strip. He overshot and made a second approach to runway 13.
