AIB Bulletin

AIB Bulletin No. 6/01

Aircraft Type & Reg: Piper PA34-200T Reg: 5H-AZT Serial No.7570151

Location: Zanzibar Airport (061 40 S 039.16 E)

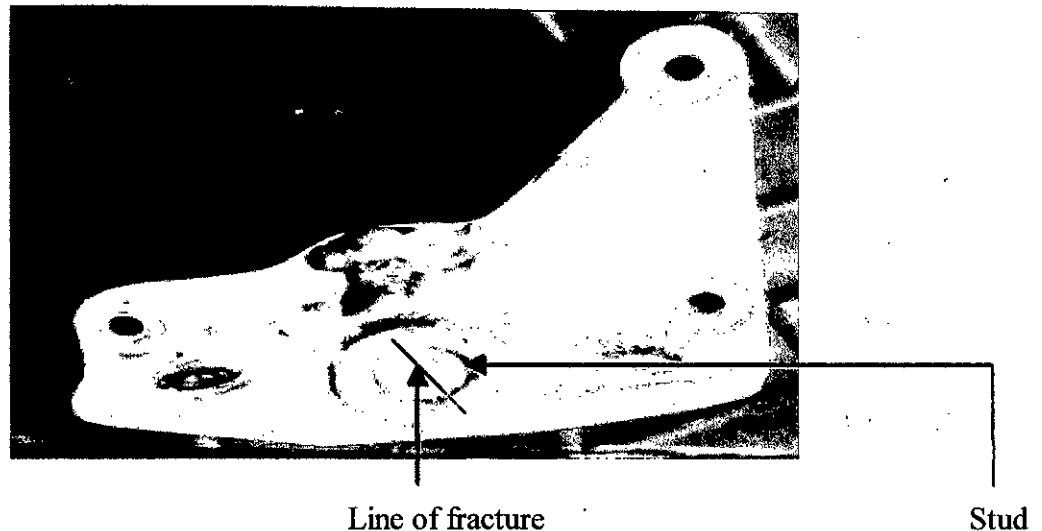
The crash site

Examination on the aircraft indicated that the LH main gear side brace stud had suffered a fatigue fracture. This caused the LH main gear to collapse resulting into the left propeller strike and the aircraft resting on its left wing. These caused damage to the left main gear, left propeller, the left wing both the undersurface and the upper surface which was pierced by the gear actuator rod and the rear bottom of the fuselage which was scratched.

Tarmac surface on the runway at Zanzibar Airport. There was minor damage to the runway surface.
