AIB Bulletin

AIB Bulletin No. 7/00	Ref: CAV/CC/7/00	Category: 1.3
Aircraft Type & Reg.	Cessna 206 5H-CTL	Serial No. 01988
No. & type of Engines:	One Continental IO – 520F	
Year of Manufacture:	1973	
Date and Time (UTC):	30 July 2000 at 1515 hours	
Location:	Utete airstrip, Rufiji District Tanzania Lat. 07° 59' 97.6" S Long. 038° 45' 54.8"E"	
Type of Flight:	Air Charter	
Persons on Board:	Crew – 1	Passengers – 4
Injuries:	Crew – Nil	Passengers - Nil
Nature of Damage:	Substantial damage to the propeller, nose landing gear and fuselage underside structure. Damage considered beyond economic repair.	
Commander's Licence:	CPL	
Commander's Age:	28 years	
Commander's Experience:	1356 hours of which 216 were on type Last 90 days 139 hrs Last 28 days 69 hrs	
Information Source:	Telephone call from Rescue Co-ordination Centre.

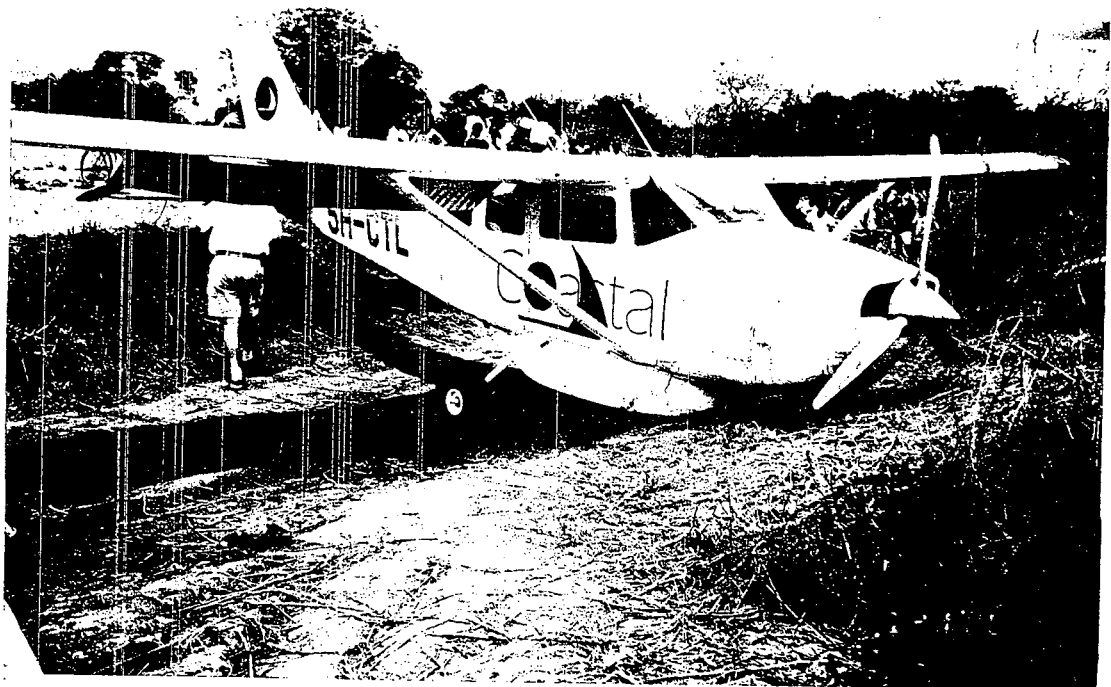
5H - CTL landed 150metres beyond the beginning of runway 27. It continued to roll till it overran the end of the runway and plunged into a road running just beyond the runway. The road is five feet below the elevation of the runway and runs perpendicular to directions 09/27. The aeroplane came to rest on the road.

There was no fire and the occupants disembarked without injuries. The aeroplane sustained substantial damage to the nose landing gear, the propeller and the fuselage underside structure.
