AIB Bulletin

AIB Bulletin No. 9/00 **Ref.:** CAV/ACC/9/00 **Category:** 1.2
Aircraft Type & Reg. Beech BE-58 **Reg.** 5H-NAB **Serial No.** TH-789
No. & type of Engines: 2 Continental IO-520-CTB
Year of Manufacture: 1977
Date and Time (UTC): 12 August 2000 at 1147 hours
Location: Mamire airstrip, Tarangire near Babati
Lat. 04° 09' 66" S Long. 035° 55' 48"E
Type of Flight: Air Charter
Persons on Board: Crew - 1 Passengers - 2
Injuries: Crew - NIL Passengers - NIL
Nature of Damage: Extensive damage to both wings, propellers, landing gears and fuselage underside structure.
Commander's Licence: CPL
Commander's Age: 43 years
Commander's Experience: 8,300 hours of which 220 were on type
Last 90 days 86 hrs
Last 28 days 9 hrs
Information Source: Telephone call from the operator

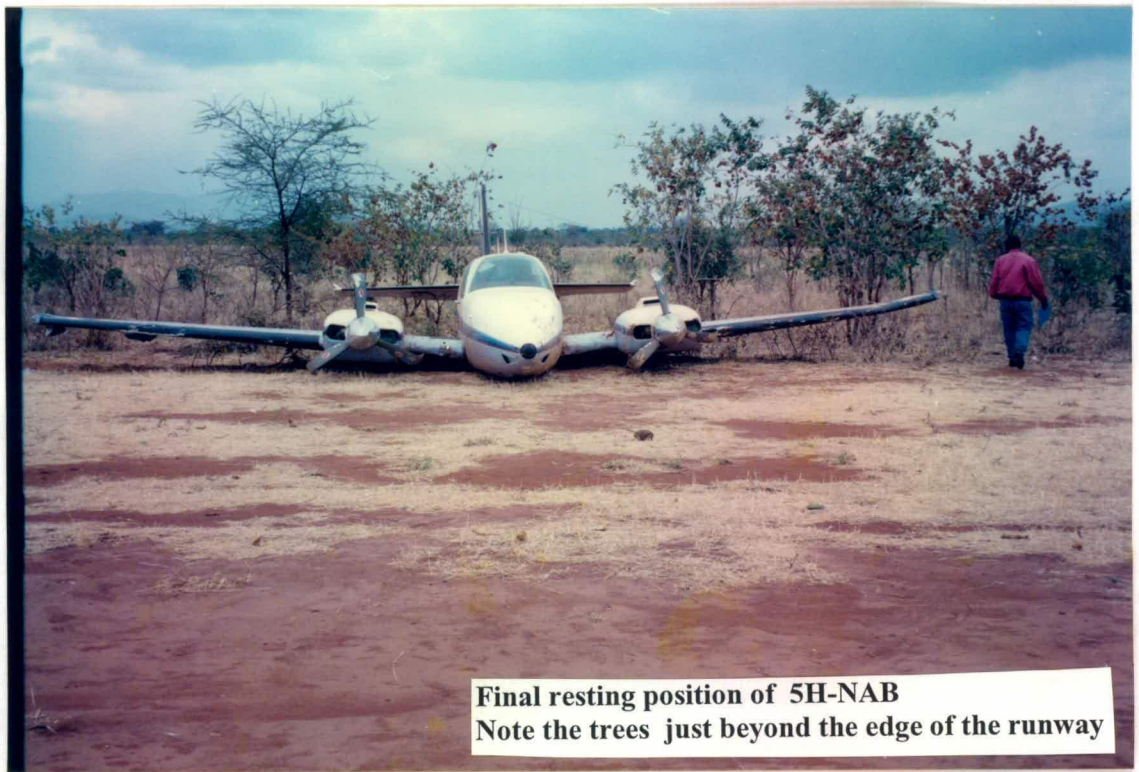
From the position where the nose landing gear doors were found the wreckage continued scrape the ground for a further 85 metres before it came to rest at the edge of the runway. As it did so, it collided with a number of small trees.

Fuel tanks were ruptured but there was no fire. All the three occupants escaped without injuries. The aircraft suffered extensive damage to its landing gear, both wings, both propellers and the fuselage underside structure.

Final resting position of 5H-NAB
Note the trees just beyond the edge of the runway

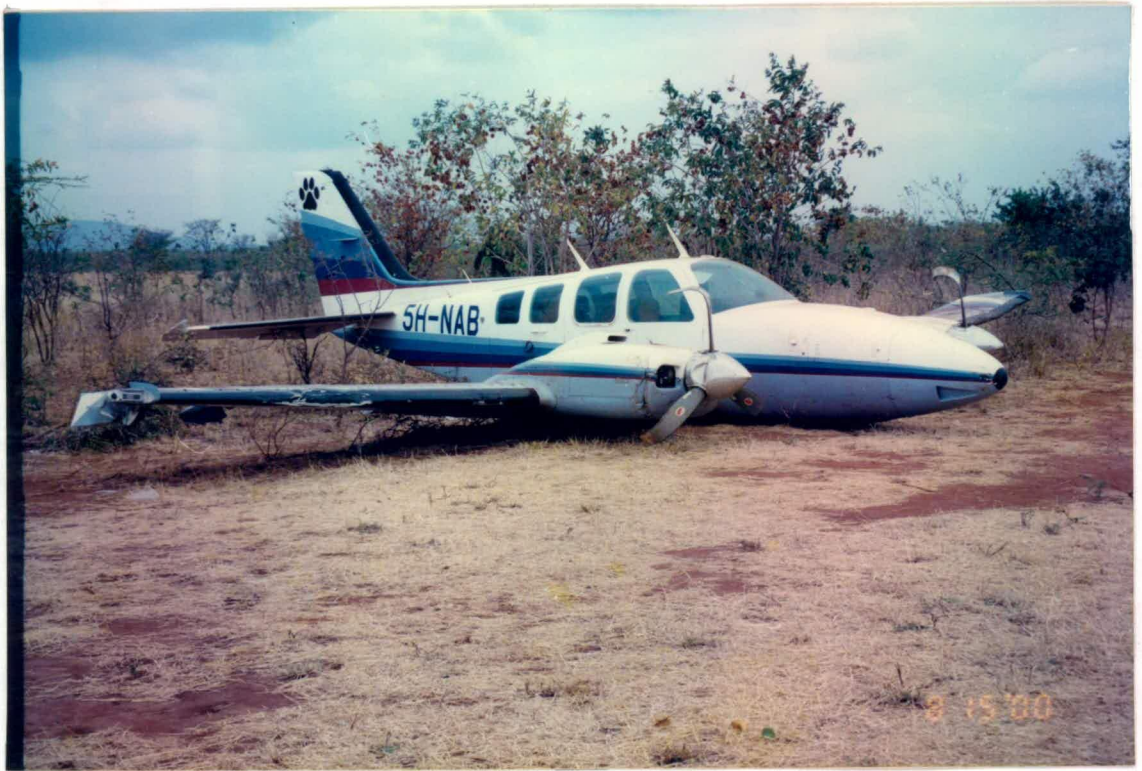
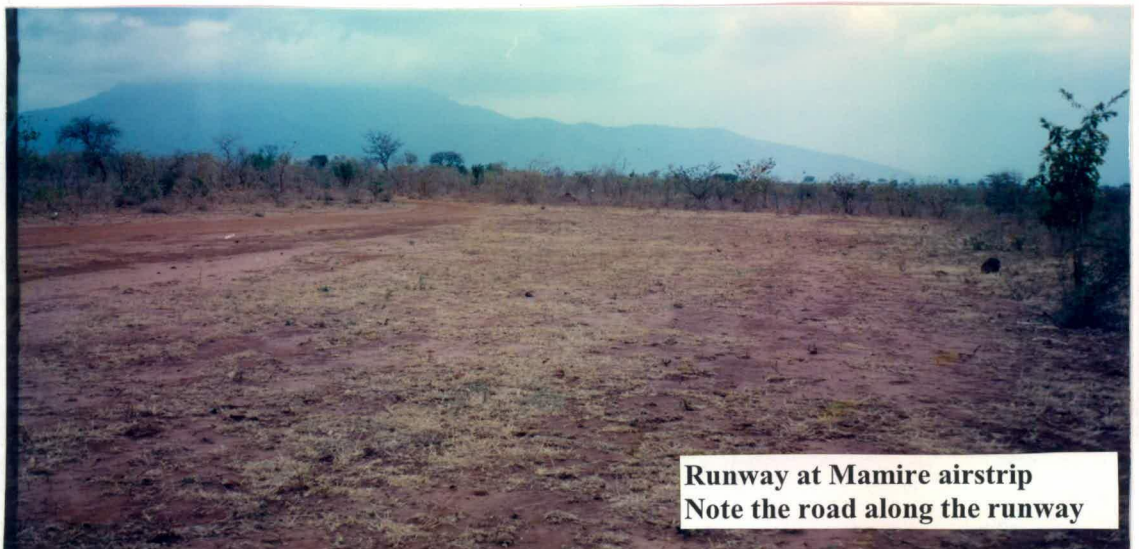
Mamire airstrip, elevation 4000 feet has one runway 08/26 which is 1200 metres long and 20 metres wide. The surface is compacted red soil with many patches of dry grass. There are many small trees and large stones located just beyond the edges of the runway. The right hand side of runway 08 is used as a road.

Runway at Mamire airstrip
Note the road along the runway
