AIB Bulletin

AIB Bulletin No. 4 **Ref.:** CAV/ACC/4/01 **Category:** 1.1
Aircraft Type: Antonov An 12 **Reg.** EK-46741 **Serial No.** 8345408
No. & type of Engines: 4 AI20M
Year of Manufacture: 1968
Date and Time (UTC): 21 July 2001 at 1240 hours
Location: Bulyanhulu airstrip, Kahama.
(03° 13.74'S, 032° 28.50'E)
Type of Flight: Air Cargo
Persons on Board: **Crew - 7** **Passengers - Nil**
Injuries: **Crew - Nil** **Passengers - N/A**
Nature of Damage: No visible damage to the aircraft. Damage to the fence located beyond the runway 09 stopway.
Commander's Licence: ATPL
Commander's Age: 49 years
Commander's Experience: Unknown
Information Source: Telephone call from the Dar es Salaam ATS

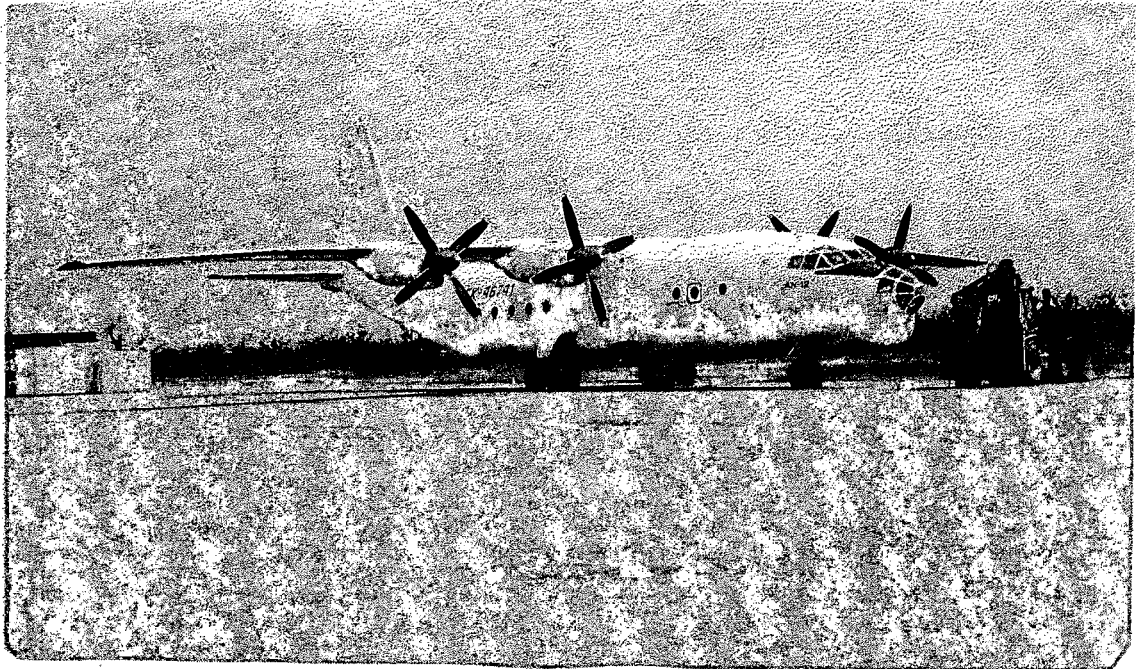
Antonov An 12 EK-46741:

Note the vehicle blocking the aircraft path to prevent
Unauthorized Departure

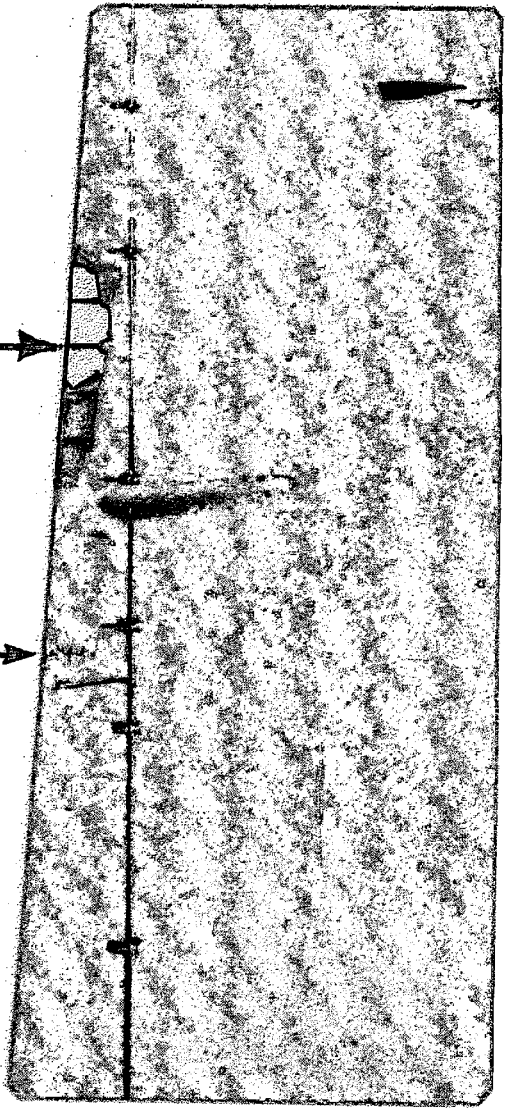
There was a large hole in the rudder, which, the crew said, was caused by a bird strike a few weeks earlier. Since the aircraft had no technical log book, it was not possible to establish when the damage was sustained. Many flights had been made with this damage "without any problems". The flight engineer said that repairs on the rudder required special trestling, which was not available in the region of operation. However, he said, the aircraft was due to fly to its maintenance base for check VIII in less than two weeks time at which place the necessary repairs could be effected. There were no records to show the maintenance status of the aircraft.

Damage to the Rudder

High speed Tape

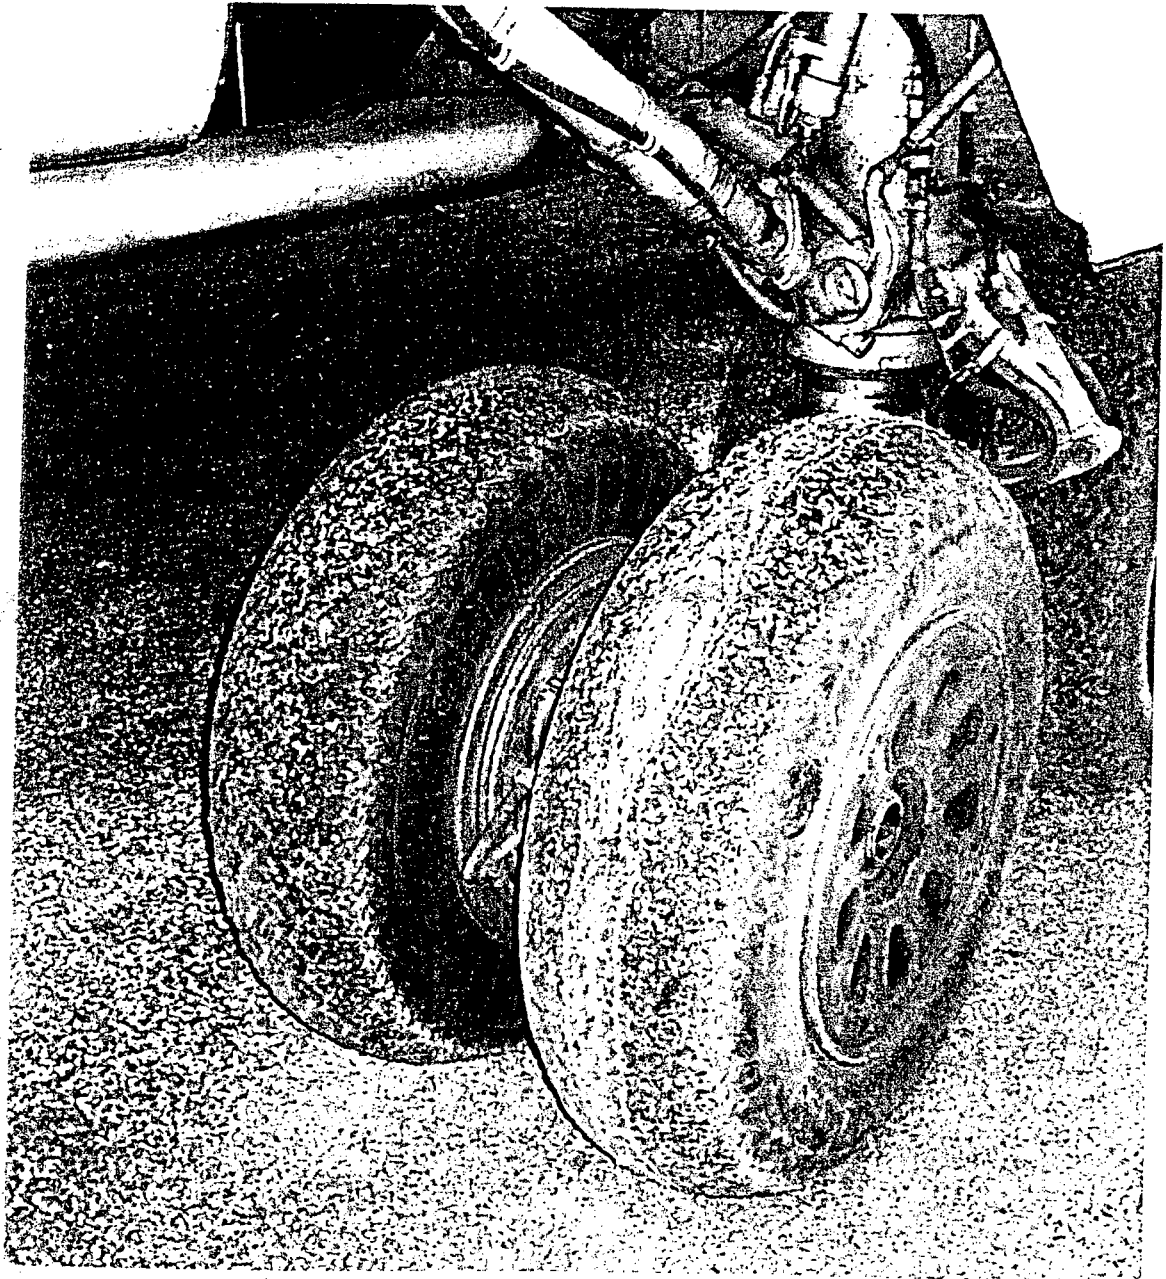
Left Hand bogie: Note No.1 Front Tyre worn much beyond the allowed number of plies.
