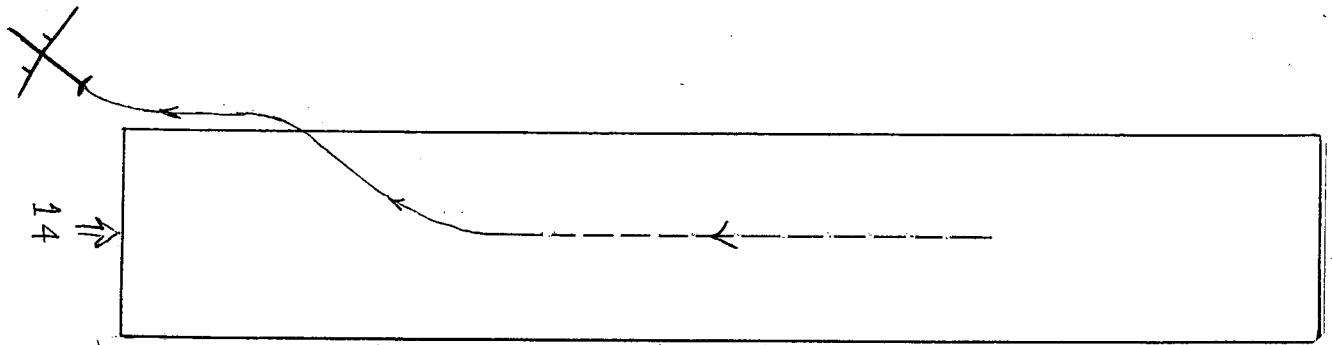
Both wings sustained extensive damage from impact with trees. The damage was more severe on the left wing, which included broken engine mounting frames. Both propellers suffered ground strike damage when the nose landing gear collapsed. There was also substantial damage to the fuselage underside structure as well as the belly cargo pod. However, there was no damage to the cabin. For this reason the occupants were able to disembark uninjured.

However, there were visible tyre marks in the middle of the runway which could be attributed to 5H-TZC. These marks started to show signs of heavy braking about two-thirds of the way down the runway. The braking was more severe on the right main tyre which appears to be the reason for the swing to the right. However, directional control appeared to have been regained shortly after the aircraft had run off the runway. Subsequent tyre marks appeared to be even on both mains.

The damage to the wings and the nose landing gear was caused by collision with vegetation when the aircraft ran off the runway. It was also evident from the wreckage trail that the left main wheel tyre had hit a stump and burst towards the end of the landing roll. This resulted in a partial loss of braking effort which appears to have caused a further swing to the right before the aircraft finally came to rest.
