# AIB Bulletin

AIB Bulletin No.                      Ref.: CAV/ACC/8/02                      Category: 1.3

Aircraft Type & Reg.:              Cessna 150G                      Reg. 5H-MPW                      Serial No. 66420

Date and Time (UTC):              28 October 2002 at 0647 hours

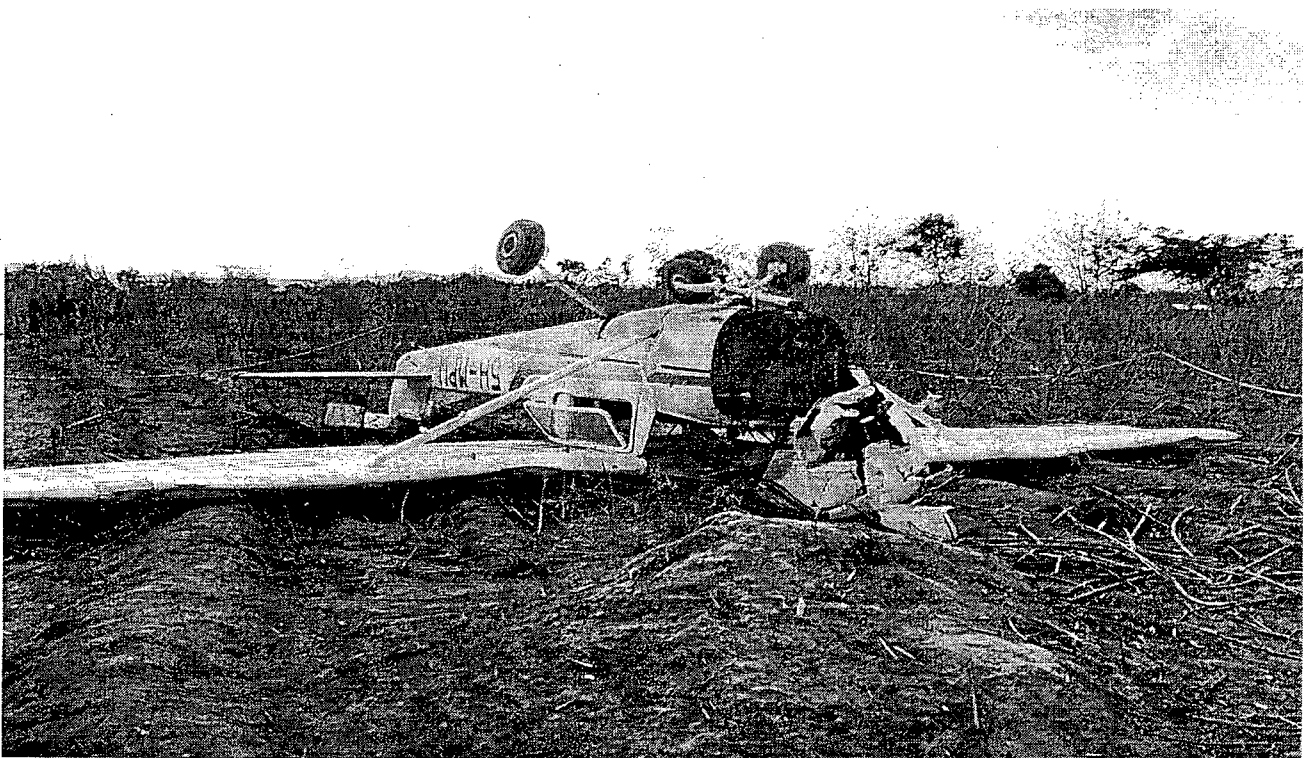
The aircraft was found lying on its back in a terraced maize field about 300 metres bearing 315° from the end of runway 32. The maize crop had already been harvested.

The fin, having been dragged on the ground when the aircraft somersaulted, was extensively damaged. However, there was no damage to both horizontal stabilizers. Both wings were damaged when the aircraft tipped over. There was fuel spillage but no fuel-fed fire broke out.

The propeller was bent at one tip. However, it showed no rotational damage and there were no ground slash marks indicating that it was not under power at the time of the impact with the ground. The pilot reported that he shut down the engine and switched off the fuel just before touch down. It would appear that when the nose landing gear struck an ant hill and separated in the accident sequence, the propeller dug in causing the engine to shear off its mounting frame tubes and the aircraft to tip on its back.

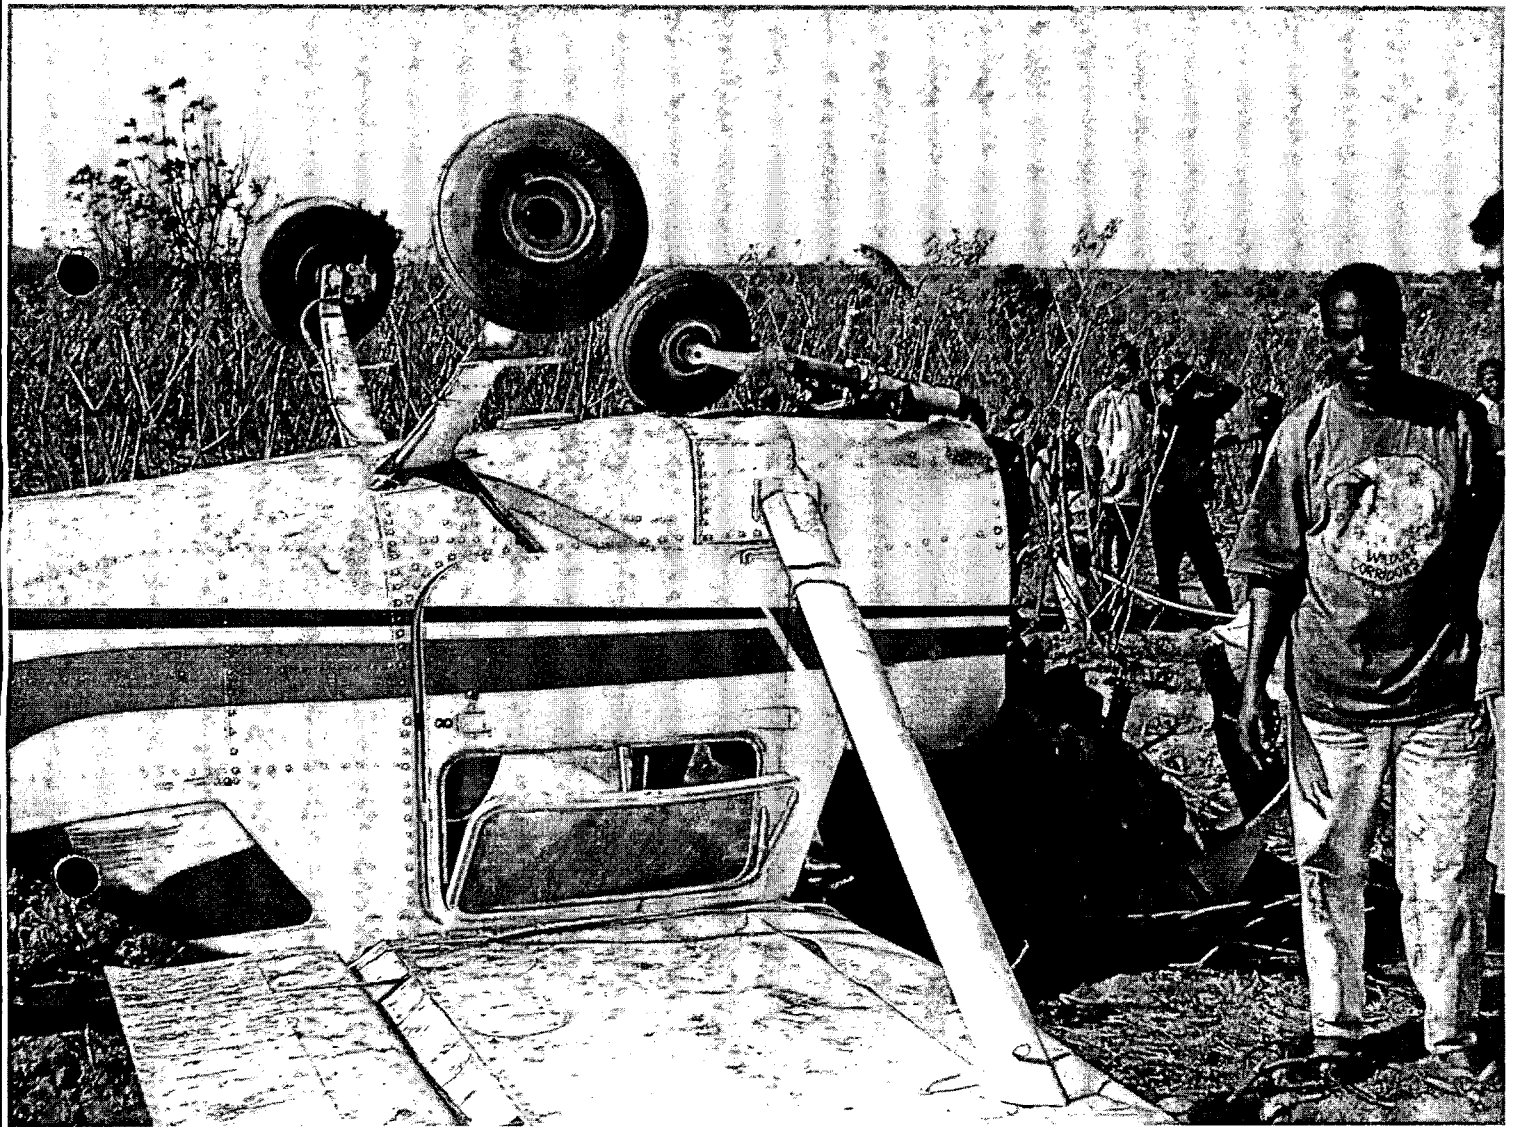
During the landing roll the aircraft struck an anthill, which sheared off the nose landing gear causing the propeller to dig in, and the aircraft to tip on its back before it came to rest. The passenger disembarked uninjured but the pilot sustained a minor injury to his chin. There was no third party damage. A small fire was seen on the engine but was quickly extinguished by the airport fire brigade.
