REPORT ON AIRCRAFT INCIDENT WHICH OCCURRED ON  
SUPER VC.10 5H-MOG - ON 10TH JANUARY, 1976

AIRCRAFT: SUPER VC-10 (1154) 5H-MOG - CONSTRUCTORS NO.885.  
OPERATOR: EAST AFRICAN AIRWAYS.  
SITE OF INCIDENT: NAIROBI-LONDON (DIVERTED ROME).  
CREW: TOTAL VC.10 HRS.  
CAPTAIN BRITCHFORD. 3933.56  
F/O MU YA 150.00  
E/O SERNA 1310.48  
N/O WARNER 3000.00  
F/O DOLASIA (SNY) 910.00  
PASSENGERS: 155 - UNINJURED  
SERVICE NUMBER: EC 660 NAIROBI LONDON DIRECT.  
DATE AND TIME OF DEPARTURE: 10TH JANUARY, 1976 - 10.35 A.M. LOCAL

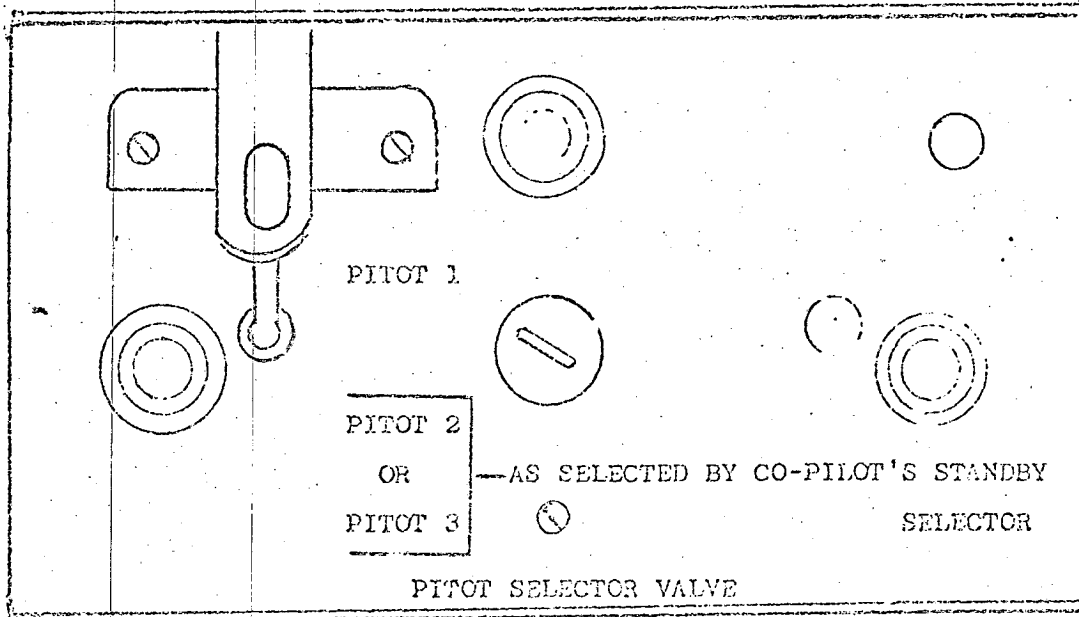
ALTERNATIVE PITOT CONTROLS AT LEFT CONSOLE  
(CAPTAIN) FIGURE 1.

The commander stated that during the initial climb, in order to diagnose the pitot system malfunction the Pitot selector Valves (see Appendix A) located on the lower portion of the Left and Right Consoles were operated and that this had the effect of transferring the high readings observed on the Starboard instruments to the Port instruments. Accordingly he decided to return them to their normal positions. On doing so on his own panel he had assumed the trainee co-pilot to have done the same although no specific instruction to do so was issued. The commander further stated that he was unable to confirm the position of the co-pilot's selector as it was not visible from his seat.

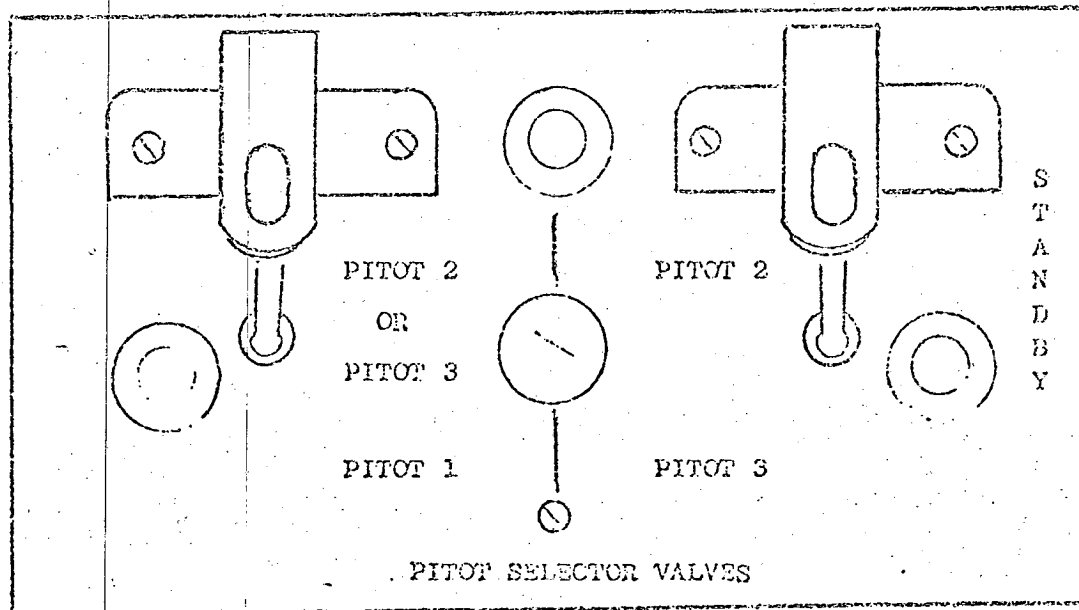
ALTERNATIVE PITOT CONTROLS AT RIGHT CONSOLE  
(CO-PILOT) FIGURE 2.

The trainee co-pilot stated that in an endeavour to assist in the investigation, he, together with the remainder of the crew, consulted the Flight Operation Manual which, contrary to the recommended procedures contained therein for the particular set of circumstances, led to the alternate pitot source P1 being selected on his panel where - to the best of his knowledge - it remained throughout the flight. It is believed the commander had not been advised of this action which resulted in cabin pressure being exhausted to atmosphere through the commander's pitot head P1 (see Appendix B). It is impossible to calculate from the limited data available the effect in numerical terms this would have had on the commander's ASI and Machmeter at the particular height and speed of the aircraft when the selection was made, but in all probability taking into account the cabin air leak rate against P1 pressure would have been in the same order which would explain the action having gone un-noticed by him.

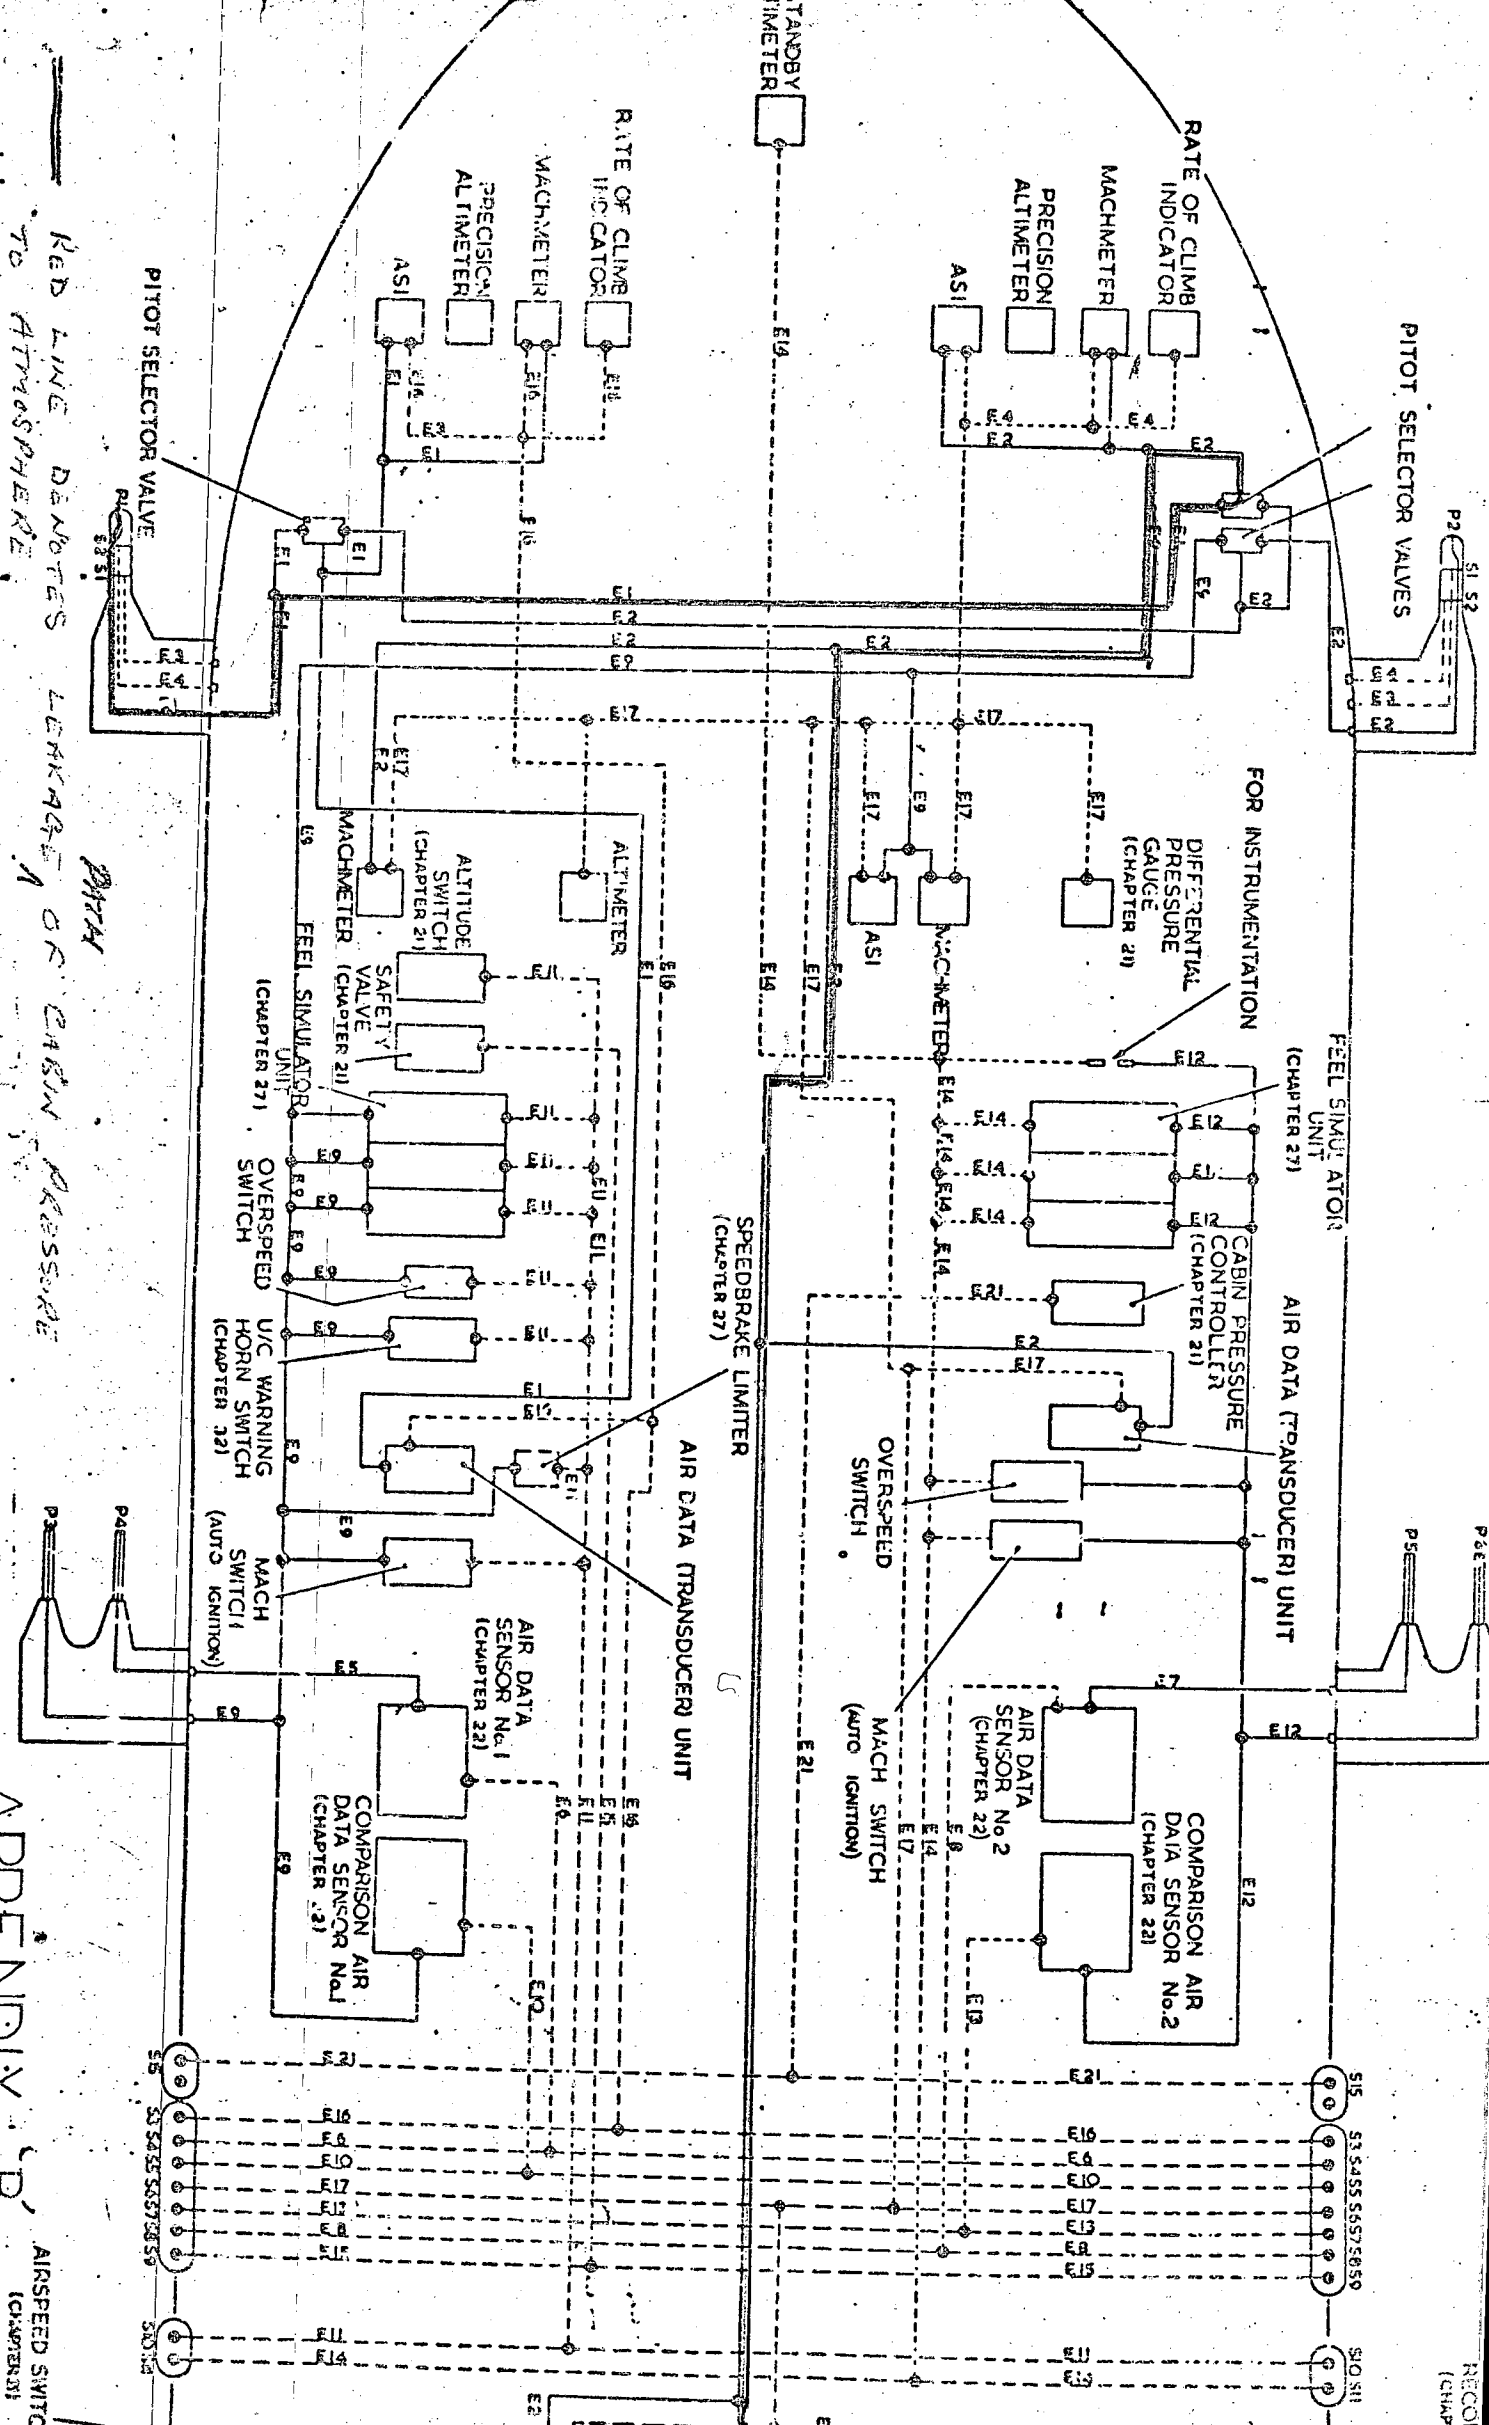
APPENDIX 'B' AIRSPEED SWITCH (CHAPTER 21)

The high ASI and Machmeter readings observed in flight were the result of cabin pressure entering the No.2 pitot system at the flight data recorder internal pitot union. For example: At FL 310 (287 Mb) assuming a cabin pressure of 8000 ft. (753 Mb) the differential pressure would have been in the order of 466 Mbs - or equivalent to 500 KTS. Taking the leak rate through the P1 pitot head into consideration the composite effect of pressure applied to the pitot system is estimated to be in the region of that displayed i.e. 400 KTS.

RED LINE DENOTES LEAKAGE IN CABIN PRESSURE TO ATMOSPHERE
