CAV/ACC/5/70

CIVIL AIRCRAFT ACCIDENT

Report on the accident to Cessna 177
Aircraft Registration 5Y-AHT which
occurred on the 1st February, 1970
at Ziwandu, Northern extremity of
the Selous Game Reserve,
Tanzania.

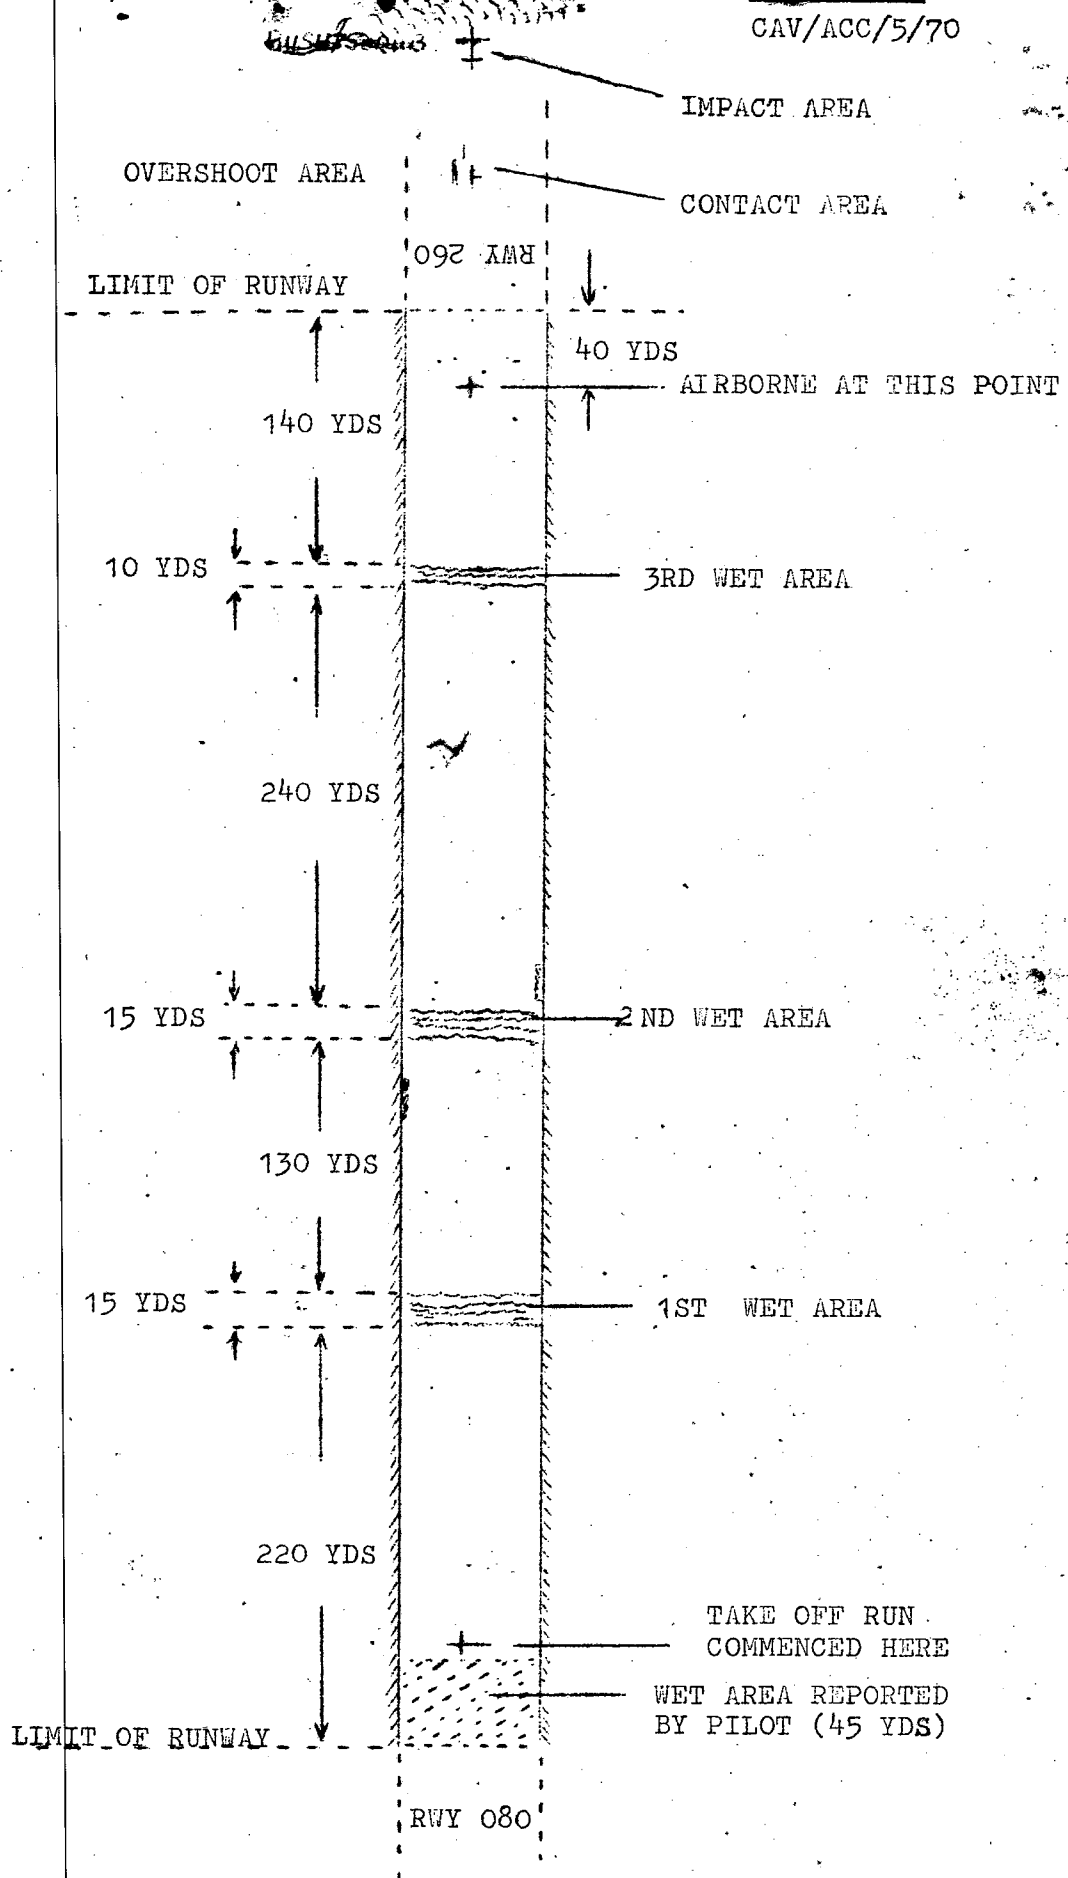
APPENDIX A
CAV/ACC/5/70

From the commencement of the runway bearing 080 there was a strip of firm ground extending for a distance of approximately 220 yards. The runway was then traversed by a patch of mud and water which extended for fifteen yards. The depth of mud and water was approximately four inches, but the surface below the mud appeared reasonably firm. 130 yards further down the runway was another patch of mud and water of approximately 2½ inches in depth. This patch extended to some 15 yards in width. Minor water and mud patches existed at the runway edges, but the centre of the runway was then firm for a distance of 240 yards, at which point a further mud and water patch extended across the runway. This third patch was approximately 10 yards in width and at a depth of 1½ inches. The remaining 140 yards of runway appeared dry and firm.

At the time of the investigation the wet patch of ground at the commencement of runway 080, which necessitated the pilot starting his take-off run 50 yards from the beginning of the runway, could not be established. However, there is no reason to believe that this patch did not exist, but accepting that this area had dried out in the interim period, it would indicate that the three mud and water areas referred to above, were at a greater depth at the time of the accident than when the survey was carried out.

At the up wind end of runway 080 the overshoot area has a decided down slope. The total overshoot area is about 150 yards in length and is bounded by trees growing to a height of approximately 45 feet. Because of the down-slope the tops of the trees are about 15 feet above the level of the runway.
