CIVIL AIRCRAFT ACCIDENT NO. ACC/11/90

REPORT ON THE ACCIDENT TO BELL 206L HELICOPTER
AIRCRAFT REGISTRATION 5H-TPF WHICH OCCURRED
29 APRIL, 1990 AT NDANDA FOOTBAL GROUND, MASASI
DISTRICT, TANZANIA

AIRCRAFT ACCIDENT REPORT NO CAV/ACC/9/90

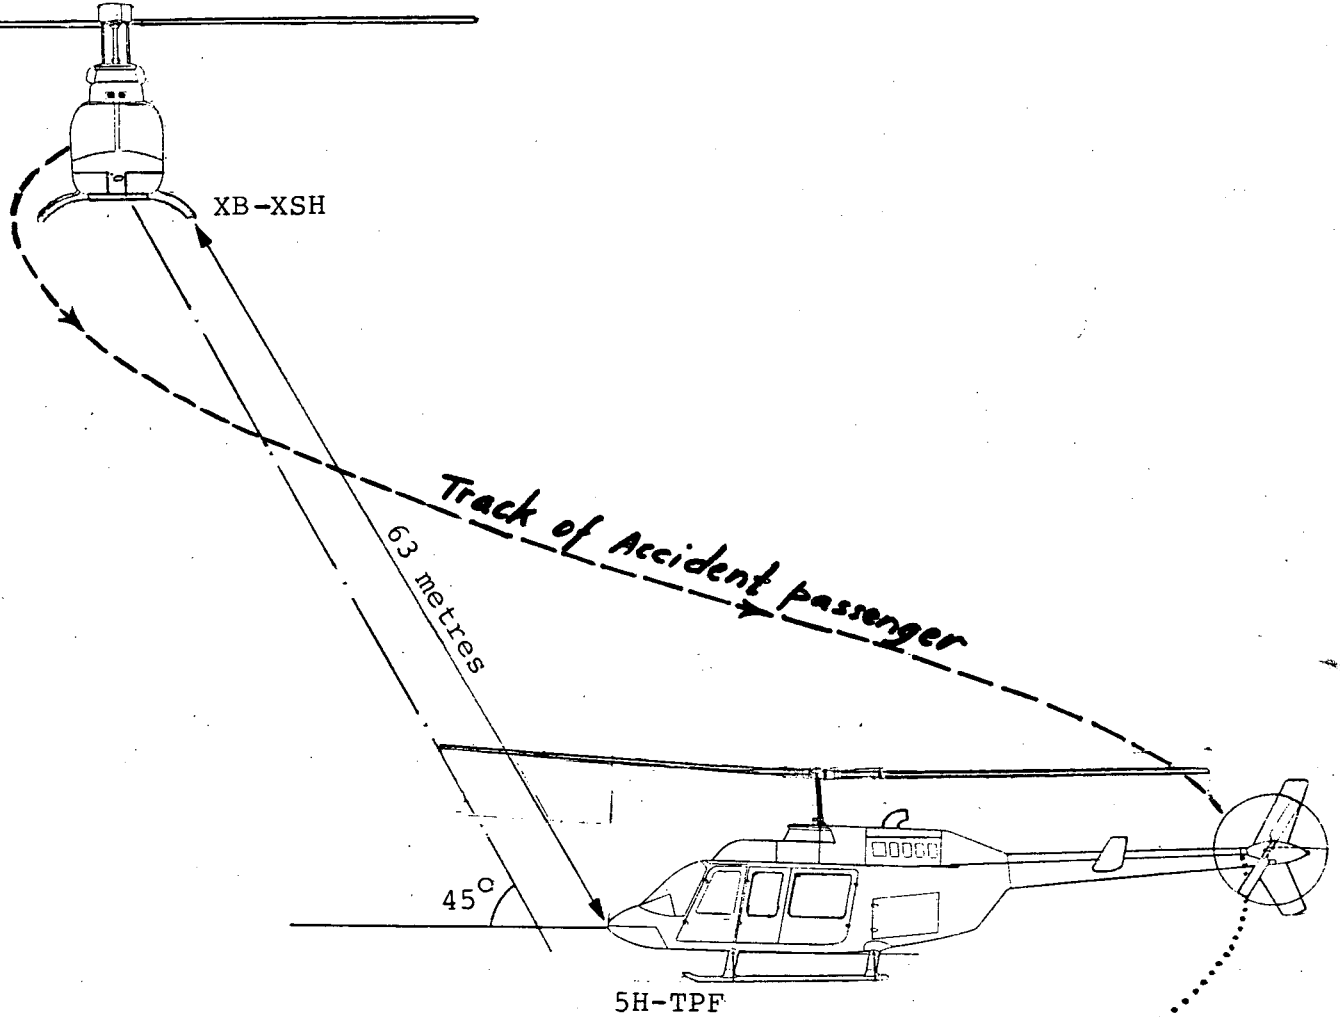
**TANZANIA POLICE AIRWING HELICOPTER 5H-TPF
ACCIDENT AT NDANDA on 29 APRIL 1990**

The two aircraft took off from Mtwara Airport at 0645 hours. They landed at Mpapula, Chekeleni and Chemchemi before they landed at Ndanda village football ground at 1040 hours. 5H-TPH was the first to land at Ndanda and HB-HSH landed one minute later. HB-XSH was parked 63 metres south west of 5H-TPF as shown in appendix 1.

5H-TPF was parked on a southerly heading on the eastern end of the football ground. This position allowed the passengers to disembark and proceed straight to the reception part which was waiting in the vicinity. HB-XSH was parked heading east 63 metres southwest of 5H-TPF. This position was to allow the passengers to disembark and join the reception partly without having to go round the back of any of the two helicopters.
