**MINISTRY OF COMMUNICATION AND TRANSPORT  
ACCIDENT INVESTIGATION BRANCH**

**CIVIL AIRCRAFT ACCIDENT No.CAV/ACC/19/97**

**REPORT ON THE ACCIDENT TO CESSNA 404  
AIRCRAFT REGISTRATION No. 5H-THF  
WHICH OCCURRED ON 26 DECEMBER 1997  
AT LOBO AIRSTRIP, SERENGETI NATIONAL PARK, TANZANIA.  
(0201S 3510E)**

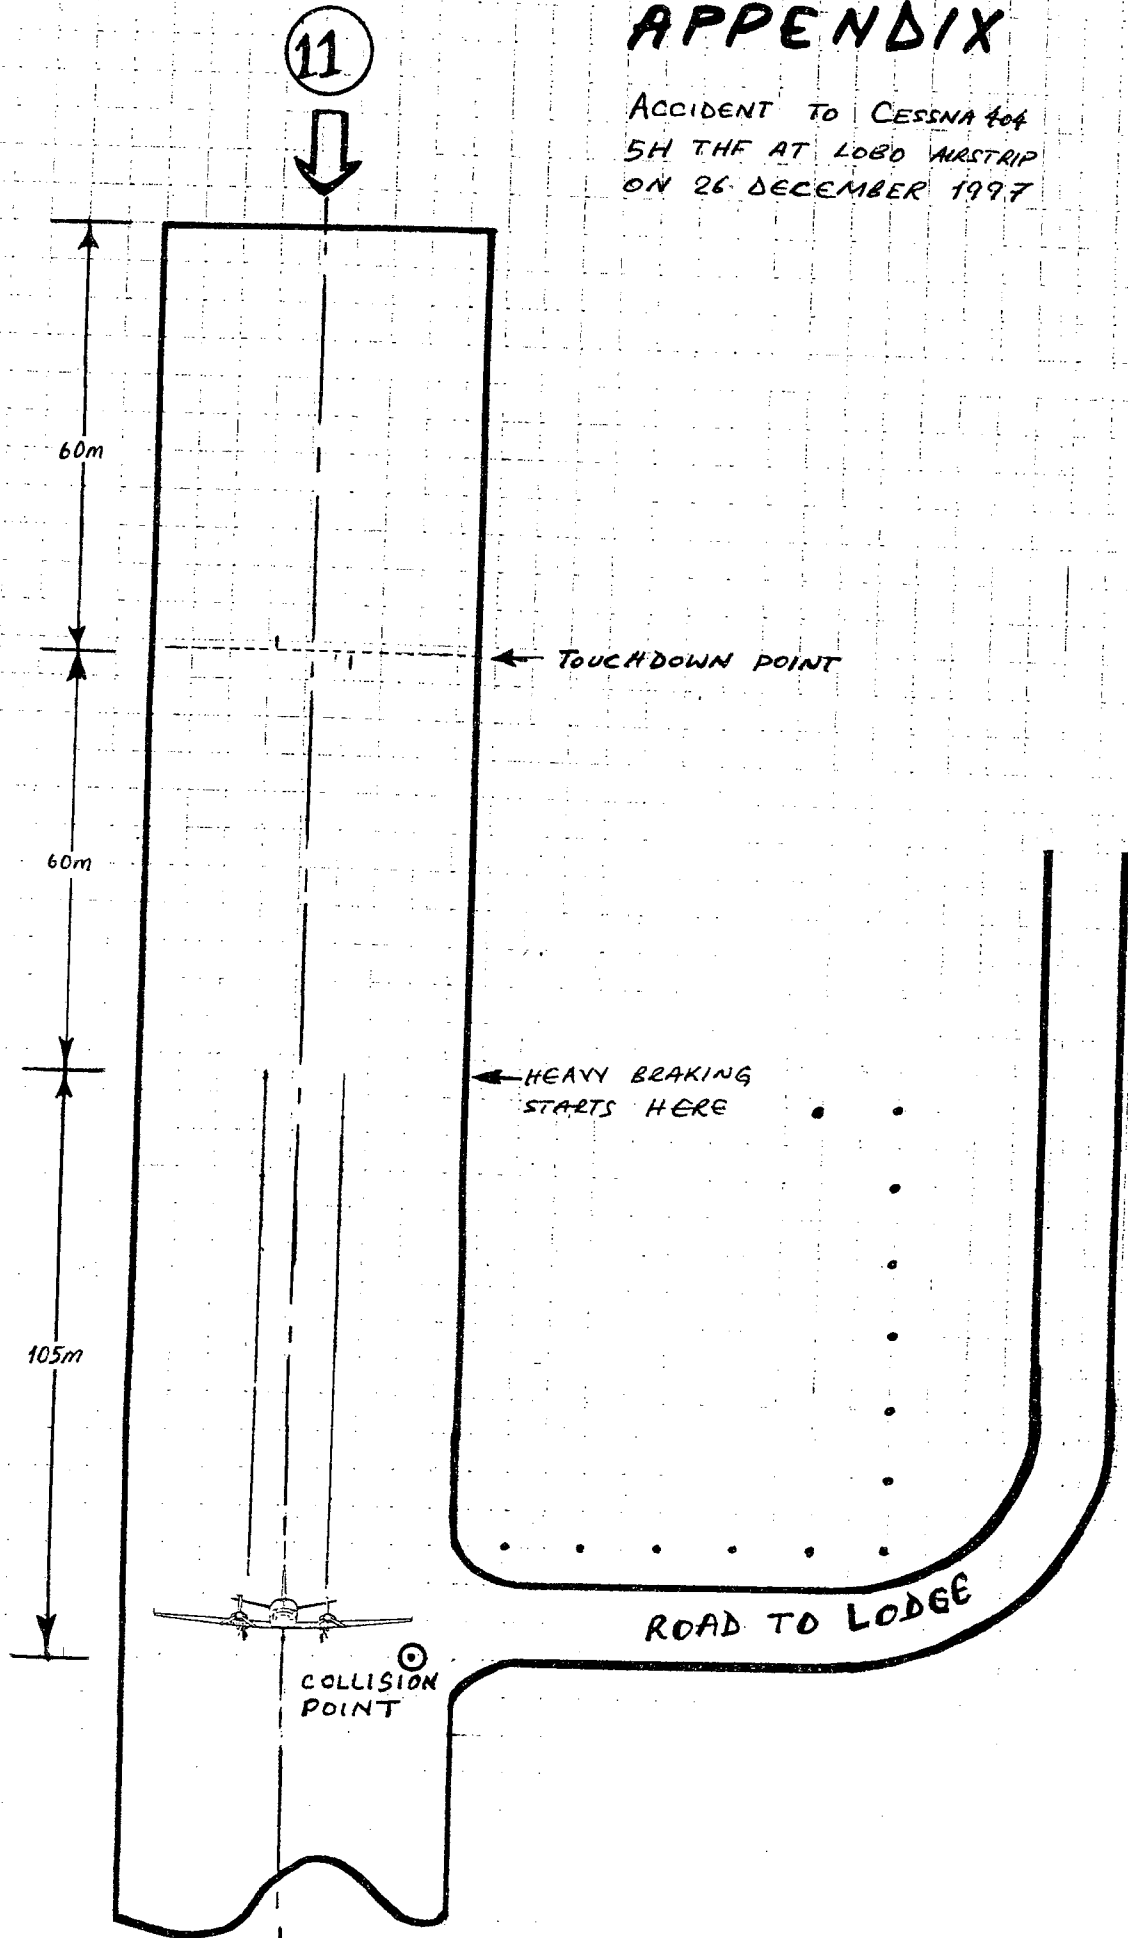
ACCIDENT TO CESSNA 404  
5H THF AT LOBO AIRSTRIP  
ON 26 DECEMBER 1997

5H-THF crossed the threshold and touched down at 1118 hours. When the aircraft had rolled another 60 metres the pilot saw a person moving from the parking area towards the runway with something that looked like a video camera in his hands. (See appendix). Due to the limited width of the runway he could not steer the aircraft to the right. He made heavy braking to slow down the aircraft but it collided with the photographer before it could be stopped.

At the point of collision with the trespasser the runway was 15.5 metres wide. The trespasser was standing 1.5 metres inside the runway and 205 metres from the beginning of the runway.

The first tyre marks attributable to 5H-THF were found 60 metres from the beginning of runway 09. The first signs of heavy braking were found some 120 metres from the beginning of the runway. The collision spot was located 85 metres from the point where heavy braking started.

It is also probable that he thought that the aircraft would be able to slow down and turn for parking on the apron as the Cessna 206 had done 40 minutes before. (See appendix)
