MINISTRY OF WORKS, COMMUNICATION AND TRANSPORT

ACCIDENT INVESTIGATION BRANCH

CIVIL AIRCRAFT ACCIDENT NO. CAV/ACC/4/94

REPORT ON THE ACCIDENT TO CESSNA 402B
AIRCRAFT REGISTRATION 5H-MPR WHICH OCCURRED
ON 6 MARCH 1994 AT ARUSHA AIRPORT, ARUSHA, TANZANIA
(03° 22'S 36° 38'E)

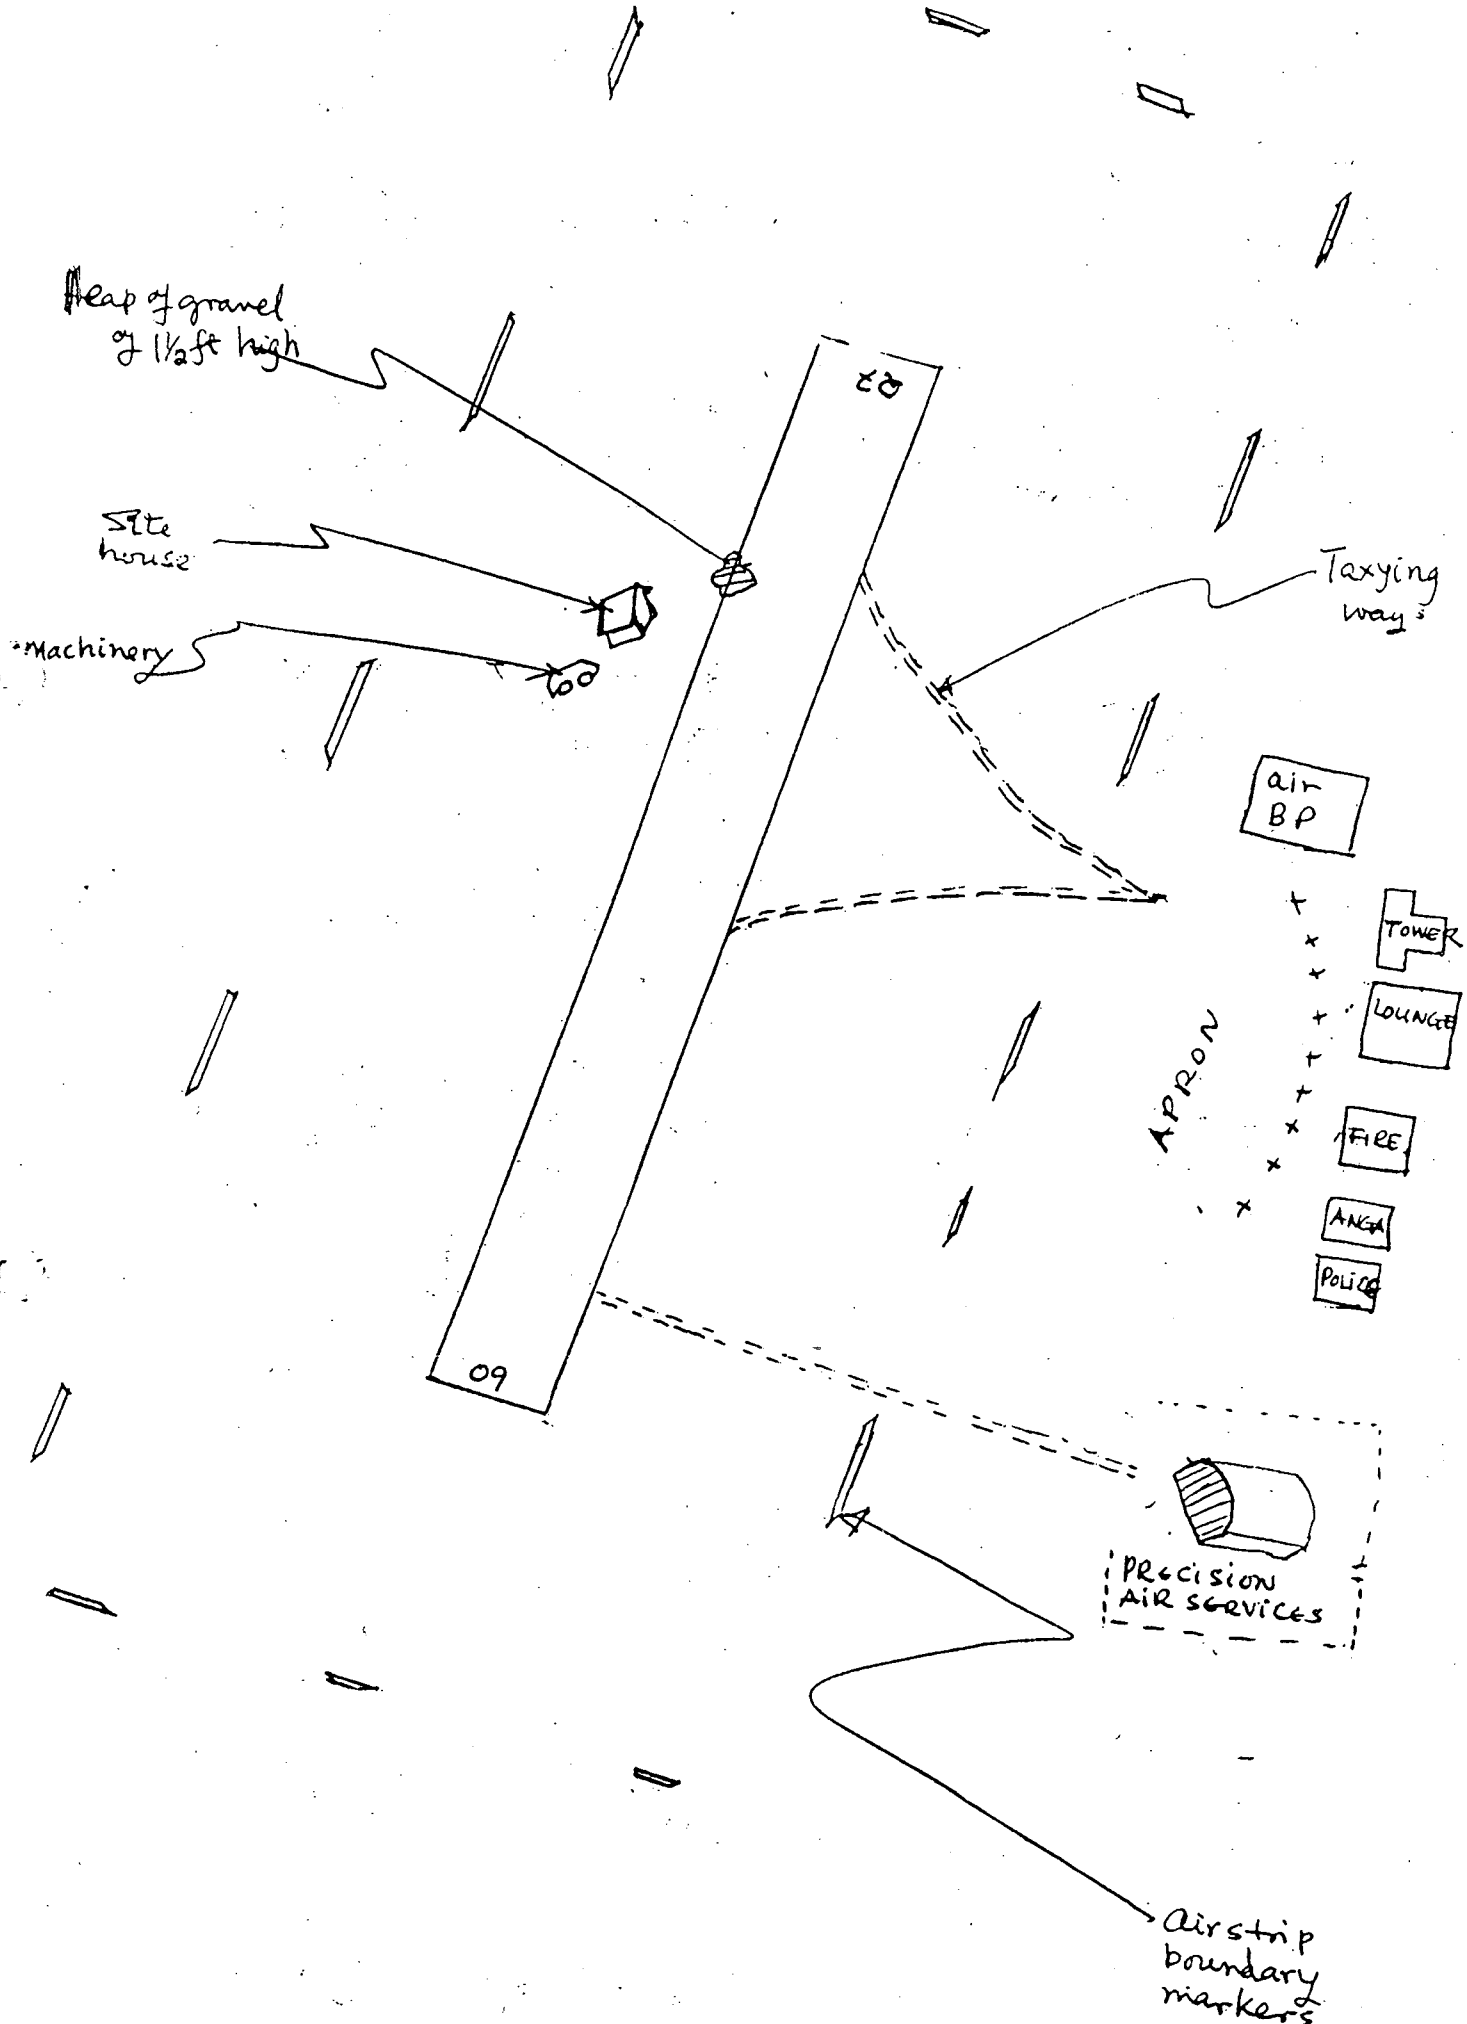
ARUSHA AIRSTRIP
ON 06-03-94 with 5H-MPR

With the company of the airport's operations Manager the pilot proceeded to inspect the runway in order to establish the cause of the bang. In the course of the inspection it was found that the left main gear leg had impacted a heap of gravel which was near the edge of the runway (see appendix 1). This heap was about 18 inches (46 cm) tall.

Arusha Airport, elevation 4550 feet (1387m) has a single runway 09/27 which is 5380 feet (1639m) long and 105 feet (32m) wide. Part of the runway had recently been re-surfaced with bitumen and gravel. At the time of the accident there was gravel (see appendix 1) in form of a cone-shaped

heap lying near the left edge of runway 09.

this gravel was left behind by the contractor who carried out the re-surfacing job some six months earlier. It was this heap of gravel which caused the accident.

The contractor who re-surfaced part of the runway was reported to have left this heap of gravel on the runway in anticipation that he would be awarded another contract to finish off the remaining part. The contractor also left some machinery and a shed on the left of runway 09 as shown in appendix 1.

The accident gravel heap was found to be 8.5 metres to the left of the centre of the runway. From the geometry of the aircraft, it has been estimated that 5H-MPR drifted about seven metres to the left during its take off ground roll.

- 4.1 The runway at Arusha Airport should have a centre-line.
- 4.2 In the light of what happened to 5H-MPR inspection of runways should be refined to include all obstacles including those located in the surrounding areas. These inspections shall be recorded and signed by competent personnel.
