AIRCRAFT ACCIDENT REPORT NO. CAV/ACC/5/89

Aircraft type : Cessna 310 H

Nationality and  
Registration Marks : 5H - CCA

REPORT ON THE ACCIDENT TO CESSNA 310H AIRCRAFT REGISTRATION  
5H-CCA WHICH OCCURRED NEAR MALONGWE RAILWAY STATION, TABORA  
ON 5 SEPTEMBER 1989.

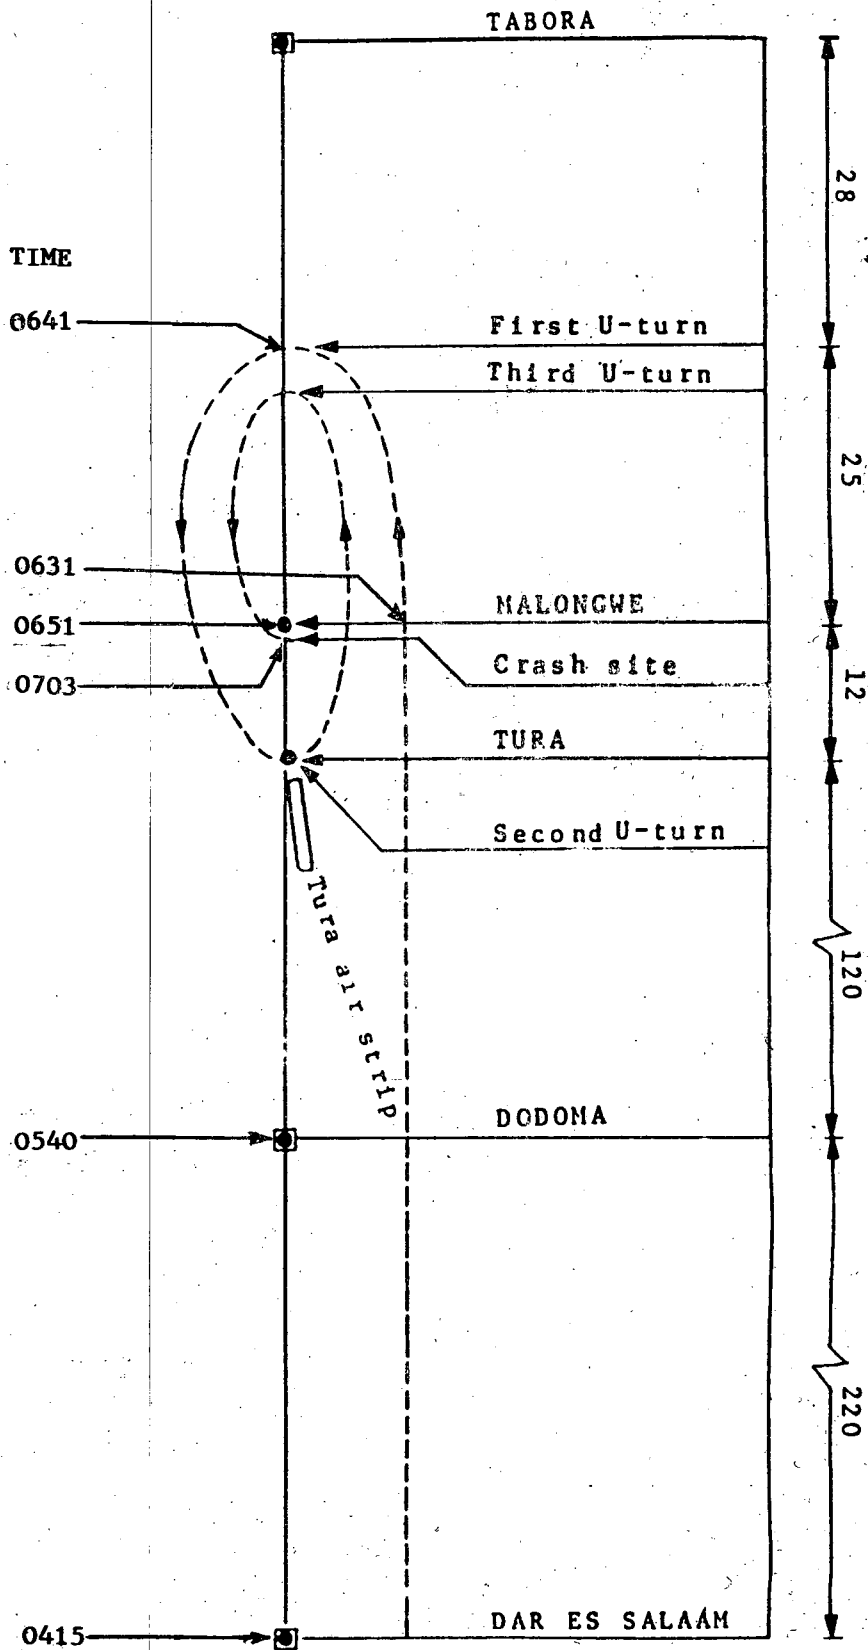
5H - CCA ACCIDENT AT MALONGWE

At the average ground speed of 155 kt the aircraft should have executed a U-turn when it was 25 n.m. west of Malongwe railway station. This position is about 28 n.m. (52 km) east of Tabora (see Appendix).
