**MINISTRY OF COMMUNICATION
AND TRANSPORT**

ACCIDENT INVESTIGATION BRANCH

CIVIL AIRCRAFT ACCIDENT No. CAV/ACC/5/99

**REPORT ON THE ACCIDENT TO BOEING 737 - 200 AIRCRAFT
REGISTRATION 5H-MRK WHICH OCCURRED IN FLIGHT
(DAR ES SALAAM - MWANZA) ON 26 MAY 1999**

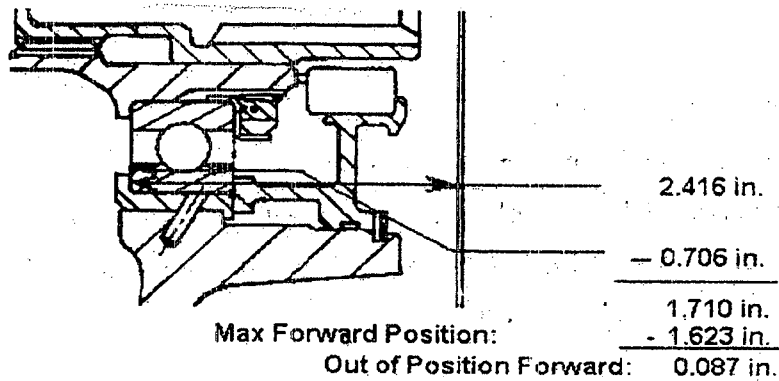
The accessory drive gear was found to have fractured radially and circumferentially through the gear rim, peeled through the gear web, and liberated an approximately 180-degree section of the gear rim that exited through the gearbox front housing. The gear tooth wear pattern, high on the tooth flanks, indicated that the bevel gear had been operating partially disengaged.

The ball bearing liner for the gear-shaft was found to be out-of-position, in the engine-forward direction by 0.087 inches, which would have allowed the bevel gears to operate partially disengaged.

- 4.1 For all grass cutting operations in the airport area all loose grass should be collected and burned or disposed.
- 4.2 The operator should do more work on crew emergency training.
- 4.3 Engineers undertaking engine overhaul should strictly follow Engine Manual (PN 481672) 72-61-01 repair section. Select the correct size (fit) for the liner, liner bore diameter for the liner selected and correct pin/holes depth according to drawing dimensions required.
- 4.4 Inspection check should be conducted to monitor the location requirements of the CSD gear-shaft liner dimension and location according the Engine Manual (PN 481 672) 72-61-01 Insp-01/Maintenance Manual (481 671) 72-60 Page 610D.

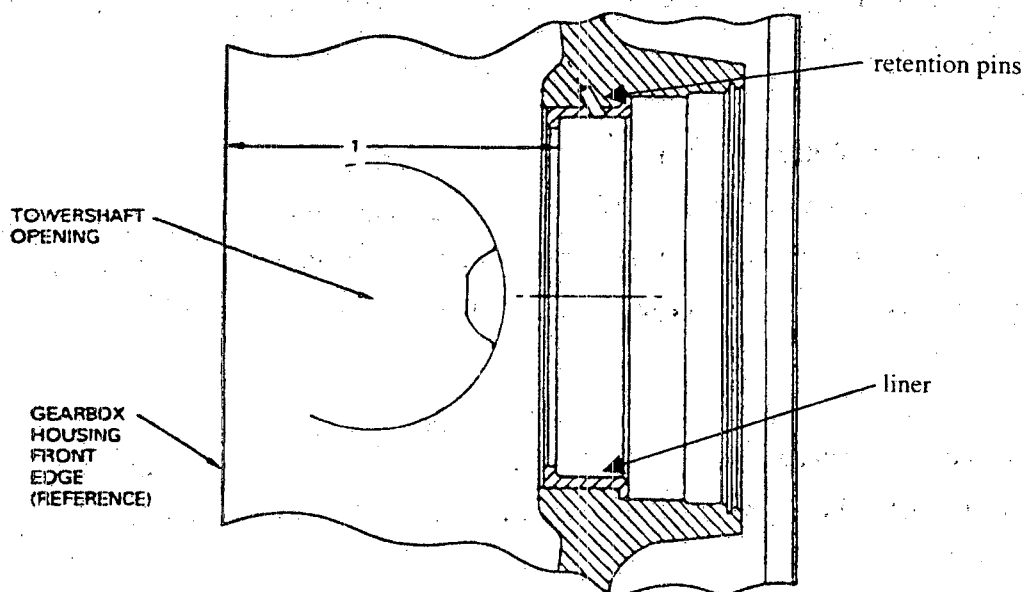
The outside diameter, specified on the part drawing, of the ball bearing liner (P3 class) is 3.794 - 3.795 inches. This diameter would have required a 0.0065 inch to 0.0090 inch interference fit. Since the liner was sectioned for removal, the actual diameter could not be determined. If the liner were at the maximum outside diameter of 3.795 inches, there would have been a near minimal interference fit of 0.0070 inches. If the liner were at the minimum outside diameter, 3.794 inches, there would not have been an adequate interference fit.

Since the holes for the retention-pins were only drilled to a depth of 0.167 inches rather than a minimum of 0.390 inches, the three bearing liner retention-pins did not prevent the ball bearing liner from moving. This movement would have promoted the observed wear to develop in the pin holes, causing fretting of the gearbox housing shoulder step, in the gearbox housing.
