**MINISTRY OF COMMUNICATION AND TRANSPORT
ACCIDENT INVESTIGATION BRANCH**

CIVIL ACCIDENT NO. CAV/ACC/7/98

**REPORT ON THE ACCIDENT TO CESSNA 150G AIRCRAFT REGISTRATION
ZS-ENR WHICH OCCURRED ON 28 MARCH, 1998 AT MBEYA AIRPORT,
TANZANIA (08 55 S 033 27E)**

**TANZANIA ACCIDENT INVESTIGATION BRANCH
AIRCRAFT ACCIDENT REPORT NO. CAV/ACC/7/98**

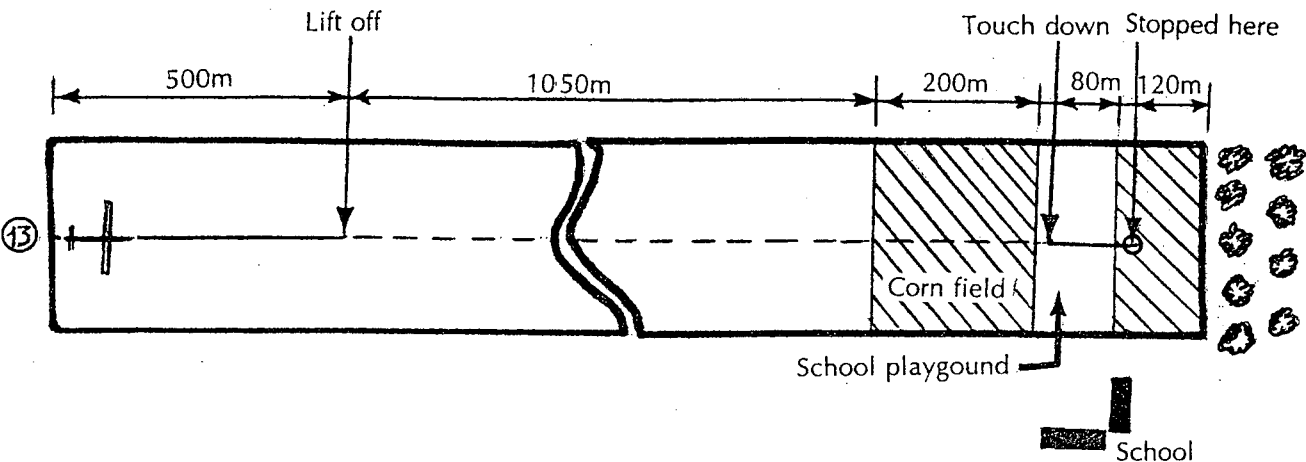
MBEYA RUNWAY AND ACCIDENT SITE

The aircraft made a successful force-landing on a school playground and stopped inside a corn field about 300 metres beyond the end of the runway 13. The aircraft was not damaged.

The aircraft landed on a school playground located 200 metres beyond the end of the runway. There were reports of the aircraft having missed some children who were playing on the school playground when it force-landed. However, the children were not injured.
