HISTORY OF THE FLIGHT

ACCIDENT TO CESSNA 404
5H THF AT L080 AIRSTRIP
ON 26 DECEMBER 1997

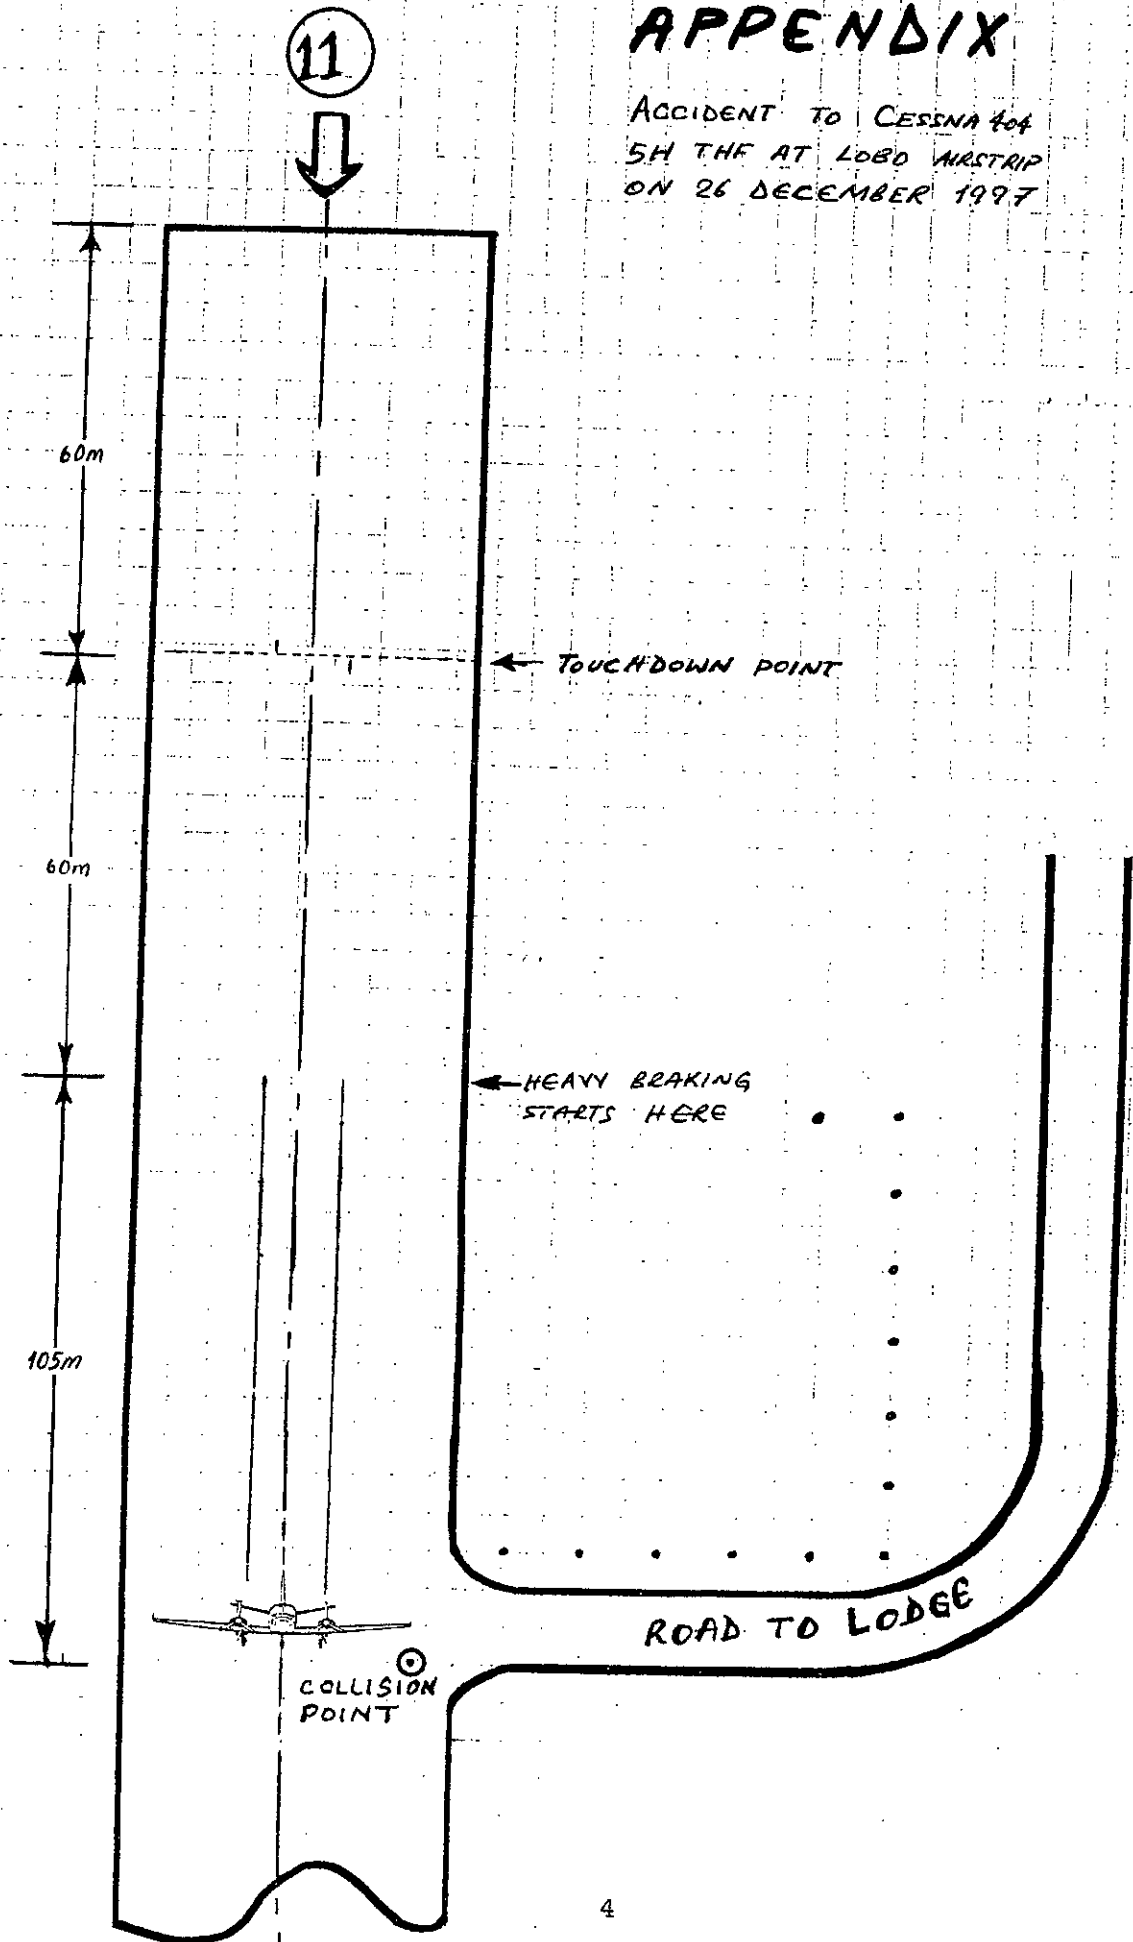
APPENDIX

5H-THF crossed the threshold and touched down at 1118 hours about 60 metres from the beginning of the runway. When the aircraft had rolled another 60 metres the pilot saw a person moving from the parking area towards the runway with something that looked like a video camera in his hands (see appendix). Due to the limited width of the runway he could not

Lobo airstrip, elevation 5500 feet (1676 metres) has one runway (11/29) which is about 1200 metres long. Its width varies from 14 to 19 metres along its length. At the point of collision with the trespasser the runway was 15.5 metres wide. The trespasser was standing 1.5 metres inside the runway and 205 metres from the beginning of the runway. Runway 11 has an uphill gradient for the first 400 metres after which it levels off. The runway surface is grass. There was no wind sock.
