THE UNITED REPUBLIC OF TANZANIA
Ministry of Communications & Transport
TANZANIA CIVIL AVIATION AUTHORITY
ACCIDENT INVESTIGATION BRANCH

AIB Bulletin

AIB Bulletin No. 2	Ref: CAV/CC/2/05	Category: 1.2
Aircraft Type & Reg.	Cessna 208B Reg. 5H-PAF	S/No. 208-0754
No. & type of Engines:	One PT6 114A	
Year of Manufacture:	1999	
Date and Time (UTC):	3 March 2005 at 0950 hours	
Location: Airport	Nyamuhongoro Damp site, 9nm east of Mwanza Airport.	
Type of Flight:	Scheduled flight	
Persons on Board:	Crew - 1 Passengers - 9	
Injuries:	Crew - Nil Passengers - Nil	
Nature of Damage:	Damage to the fin and radio antenna	
Commander's Licence:	CPL	
Commander's Age:	38 years	
Commander's Experience:	9265 hours of which 2900 were on type	
	Last 90 days 134 hours	
	Last 50 days 50 hours	
Information Source:	Telephone call from the Operator

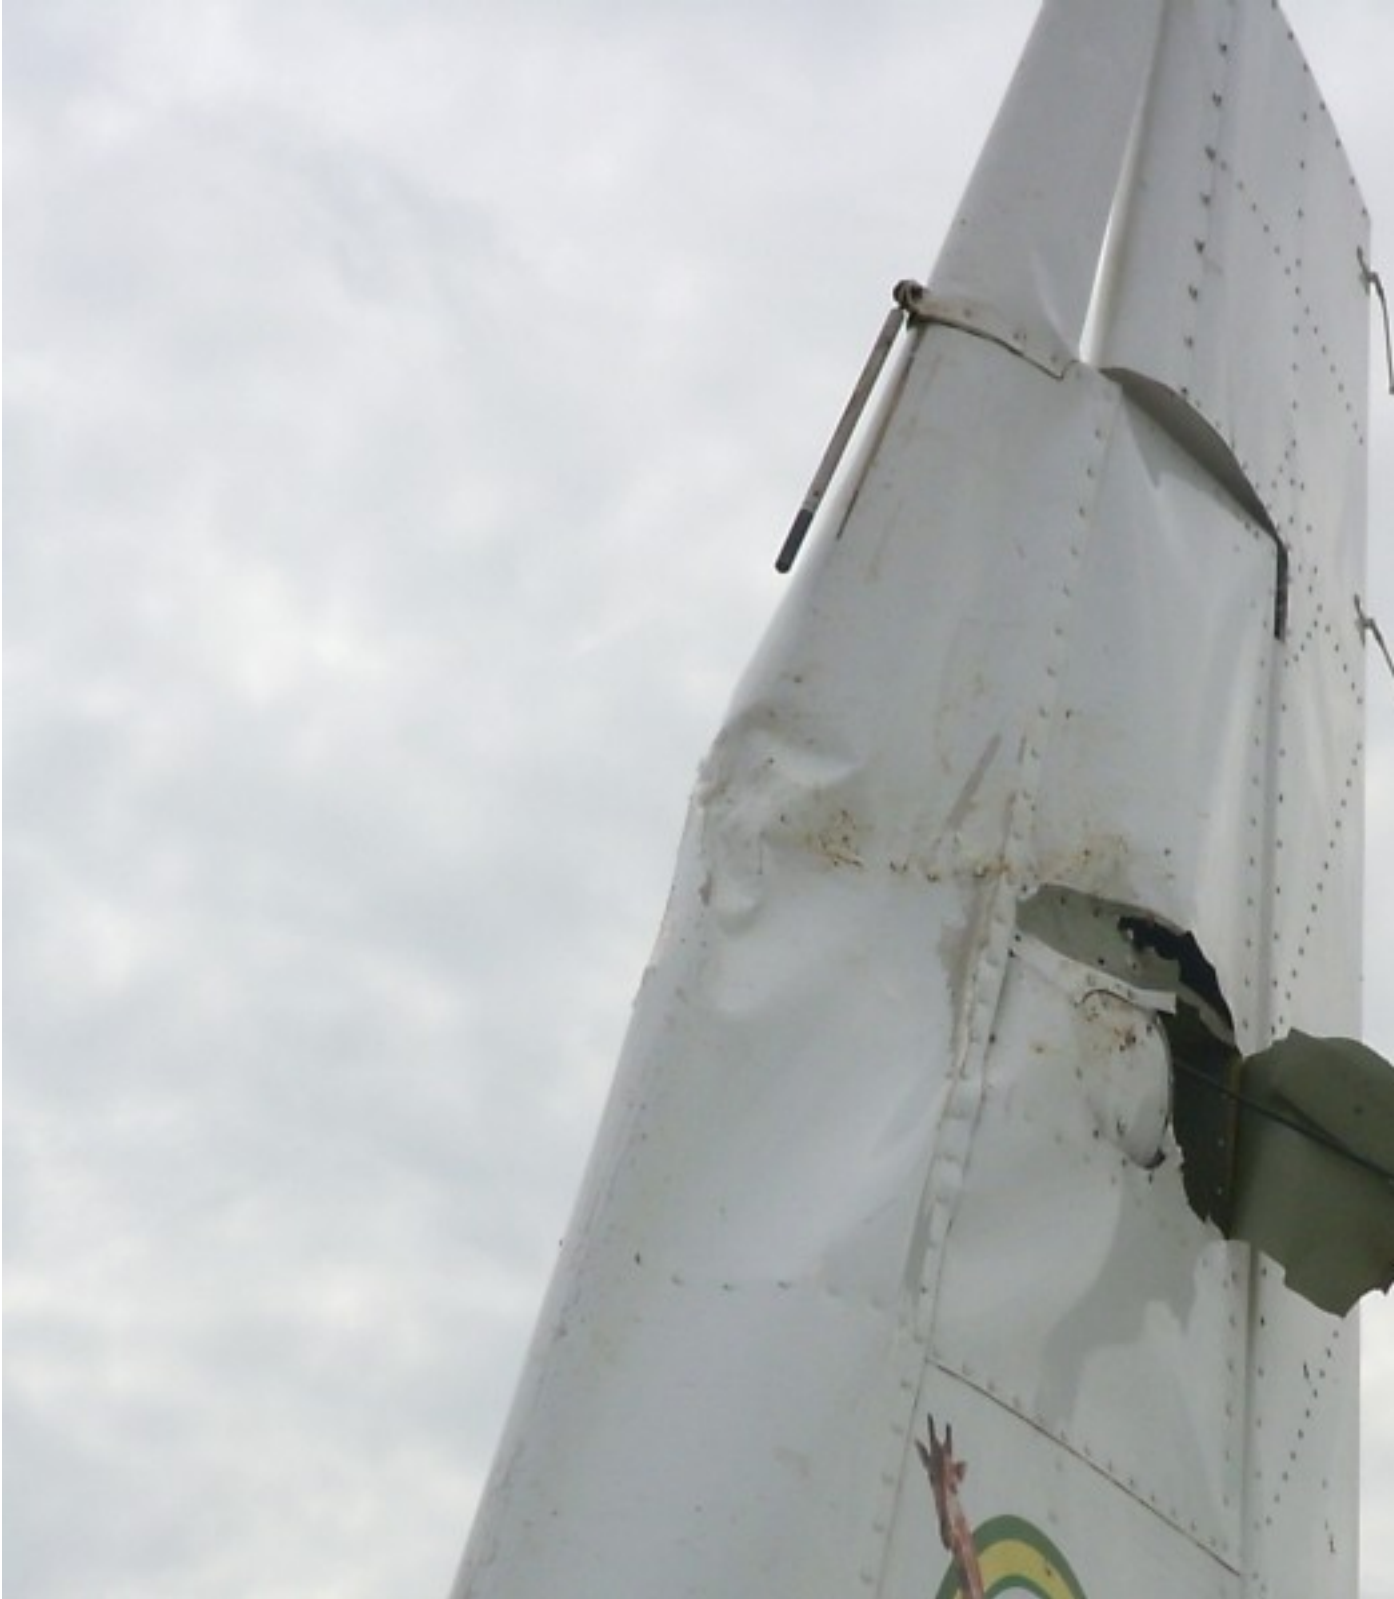
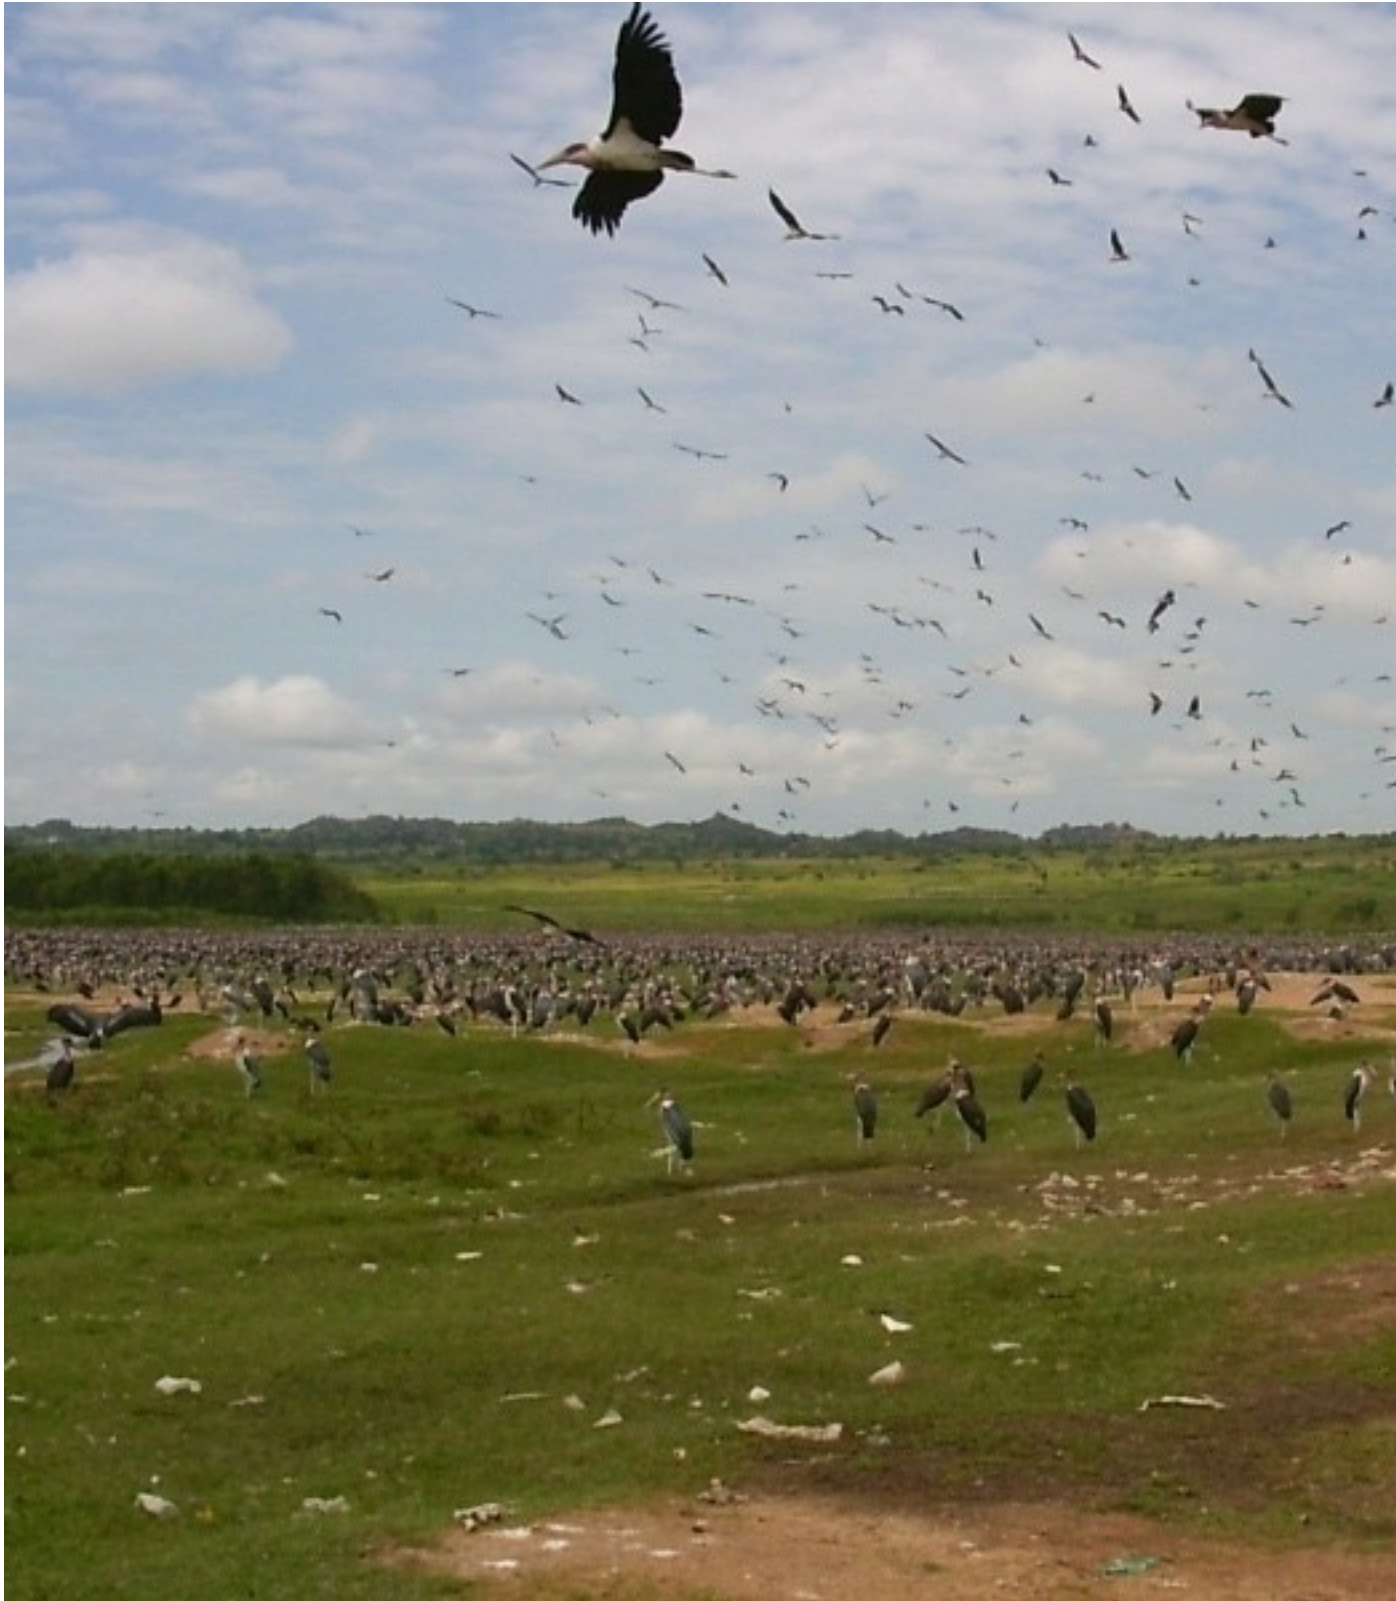
Inspections on the airframe showed damage to the fin about four feet from the top. About one square foot of the skin on the port side of the fin had been torn open. Further examination of the fin damage showed that three leading edge ribs and one main rib were damaged. The main spar of the fin was found bent.

Previous practices of removing the birds from the Nyamuhongoro area through burying fish waste failed. The Mwanza Regional Health Officer promised to move the dump site to another area (Nyegezi) which is outside the aircraft flight path. He also said that fish

waste can be completely destroyed by incineration. As a matter of long term strategy, fish factories around Mwanza, he said, will in future, be required to incinerate all fish remains.

Bird strikes in the Mwanza area can be avoided by flying in the late evening hours or at night. Most of the birds tend to rest during night hours.
