AIB Bulletin

AIB Bulletin No. 3 **Ref.:** CAV/ACC/3/01 **Category:** 1.3
Aircraft Type: Cessna 206 **Reg.** 5H-MTJ **Serial No.** 06442
No. & type of Engines: One Continental IO-520F
Year of Manufacture: 1983
Date and Time (UTC): 16 March 2001 at 0602 hours
Location: Haeseny, Yaedampay village, Mbulu District, Tanzania
(Lat 03° 59'S Long 035° 27'E)
Type of Flight: Air charter (Missionary)
Persons on Board: Crew - 1 **Passengers -** 4
Injuries: Crew - 1 serious **Passengers -** 4 serious
Nature of Damage: Aircraft completely destroyed by impact with the ground
Commander's Licence: CPL
Commander's Age: 43 years
Commander's Experience: 1795 hours of which 795 were on type
Last 90 days 92 hrs
Last 28 days 26 hrs
Information Source: Telephone call from Dar es Salaam ATS

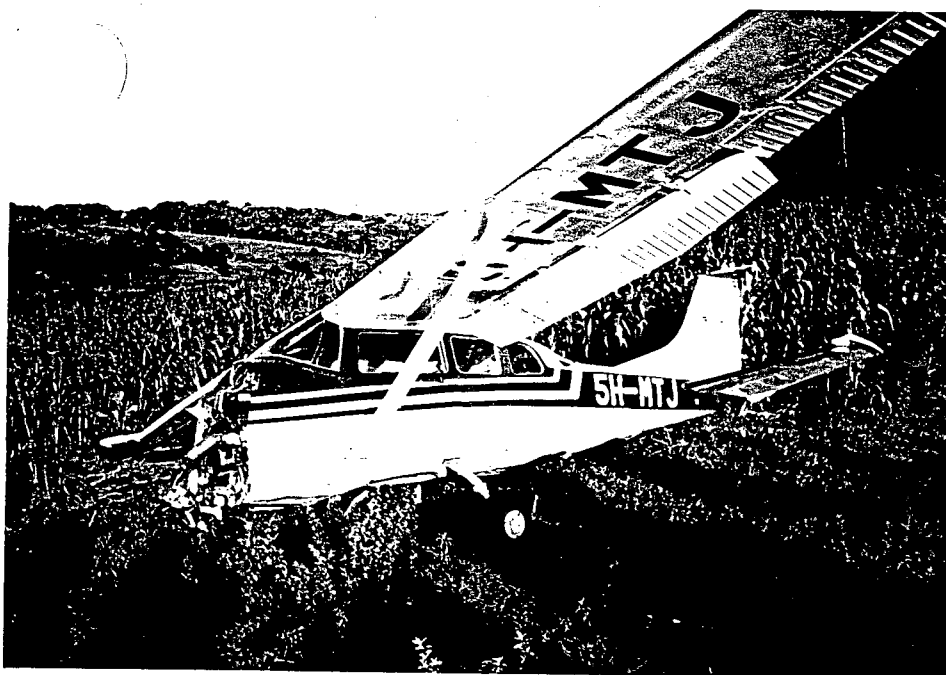
Examination of the wreckage showed that the nose wheel probably hit the ground first followed by the propeller, the baggage pod and the right wing. These together with the engine cowlings separated and were found along the wreckage trail near the point of the initial impact. The damage to the propeller indicated that it was under power at the time of impact. The engine separated from the fuselage in the accident sequence with all connections severed except the propeller control unit cable.

The right wing having struck the ground on impact was bent upward at half of the way outboard of the lift strut which was itself bent midway outwards. The left wing was not damaged. The fuselage was distorted at a number of stations. The damage to the tail plane was relatively minor.

The aircraft collided with the ground at the side of a hill overlooking a valley at Haeseny in Yaedampay village, Tumati ward in Mbulu District, Arusha Region. The elevation was 7200 feet. The surface is plain grass with maize plantations at its edge. However, there was no damage to the maize crop. A number of airmen have reported to have encountered downdrafts of varying degrees in this area. Arusha region is well known for low cloud and fog mostly occurring during morning hours and clearing gradually as the day progresses.
