THE UNITED REPUBLIC OF TANZANIA
MINISTRY OF COMMUNICATIONS AND TRANSPORT
ACCIDENT INVESTIGATION BRANCH

AIB Bulletin

AIB Bulletin No. 1 **Ref.:** CAV/ACC/1/01 **Category:** 1.1

Aircraft Type: Boeing 737-300 **Reg.** 5H-TCA **Serial No.** 24790

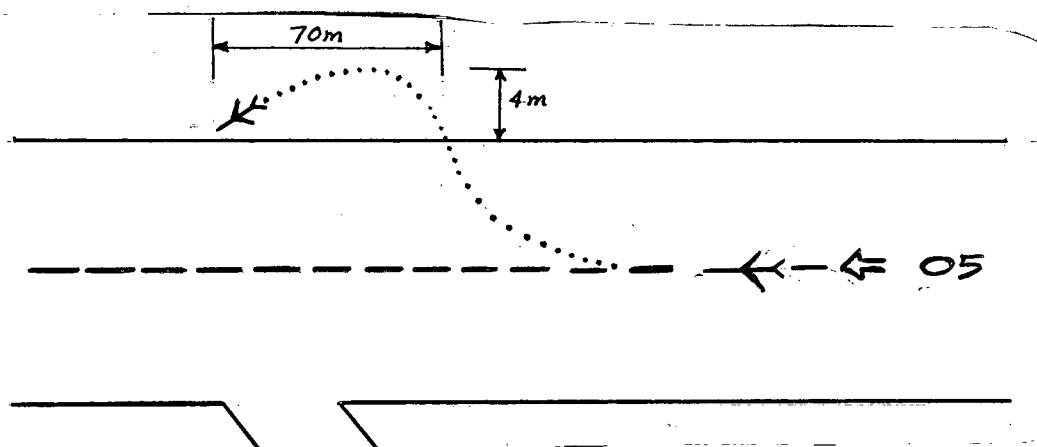
Tyre marks attributable to 5H-TCA indicated heavy braking on the nose wheel right from the runway centre-line and for the subsequent veer to the right. On entering the strip it scraped the sand surface and dug deeper just before the aircraft came to rest. However, the nose landing gear did not collapse in the accident sequence. There were also signs of heavy braking on the main wheel tyres. It was evident from the tyre marks on the ground and the tread damage to one tyre that the nose wheel had rotated on a vertical axis so that it was almost perpendicular to the direction of motion.

Examination of the aircraft showed damage to the left nose wheel tyre, which lost all its tread but remained inflated. The No. 4 main landing gear tyre also showed signs of impact damage. One fan blade in the left engine was also damaged. Substantial quantities of sand and grass were ingested by both engines. However, boroscopic inspection revealed no internal damage. All engine parameters were found to be normal on ground run. Retraction tests were performed on the landing gear. No defects were found. The nose wheel steering system also functioned normally.
